[Derailment at Dalwhinnie](#)

News story

Investigation into a derailment as a result of a signalling system fault at Dalwhinnie, Scottish Highlands, 10 April 2021.

Published 23 April 2021

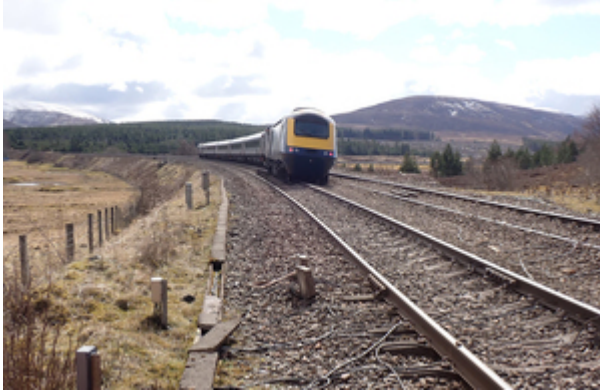
The derailed power car at the rear of the train

At around 03:03 hrs on 10 April 2021, an empty high speed train (HST), being used to check platform-train stepping distances, was wrongly diverted from the up line to the down line at a crossover located around 190 metres south of Dalwhinnie station. Before the train was able to be stopped, its rear three bogies became derailed due to the points at the north end of the crossover moving under the rear of the train.

The signal on the approach to the crossover was displaying a proceed indication for the route along the up line and there is no signalled route from there, over the crossover, to the down line. Both sets of points forming the crossover were detected as being in the correct position for the up-line route by the signalling system and were indicated as such to the signaller, even though the points at the north end of the crossover (the end nearest Dalwhinnie station) were set in a position to divert the train onto the crossover.
