Aluminium manufacturer fined £300,000 after worker crushed

A manufacturer of rolled aluminium products has been fined £300,000 after a worker was crushed under a 1.5-tonne hydraulic arm at its site in Bridgnorth.

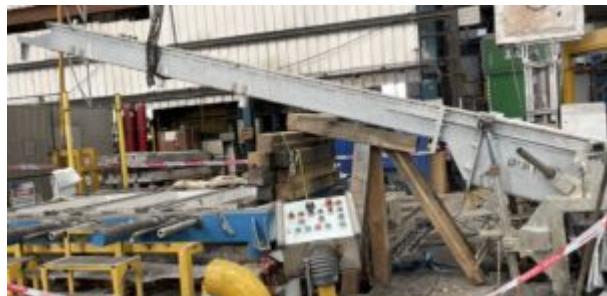
He had been carrying out preparation work for the casting of aluminium blocks from molten aluminium. He was kneeling inside a casting mould, wearing heat resistant clothing, to insert ceramic string around its edges. The hydraulic launder arm above the mould, which is used to transport molten metal around the foundry, suddenly fell onto him. It is believed the exterior temperature of the launder arm was around 100°C.

The hydraulic arm post incident

An investigation by the Health and Safety Executive (HSE) found that the arm fell as a result of hydraulic failure. While there was a safety bar intended to prevent the arm from falling, it was not fit for purpose. Bridgnorth Aluminium Limited had not assessed the risks of the hydraulic arm falling and therefore failed to implement a suitable safe system of work to prevent employees from working beneath it.

"The company subsequently implemented simple control measures to prevent it from re-occurring. The process of placing the ceramic string in the moulds is now carried out with the hydraulic arm in the lowered position, and people are restricted from walking under the it when it is raised.
