Buncefield 20 years on: Turning lessons into safer industry practices

- Two decades after one of Europe's largest industrial incidents, the legacy of Buncefield continues to shape safety standards across the UK's major hazards sector

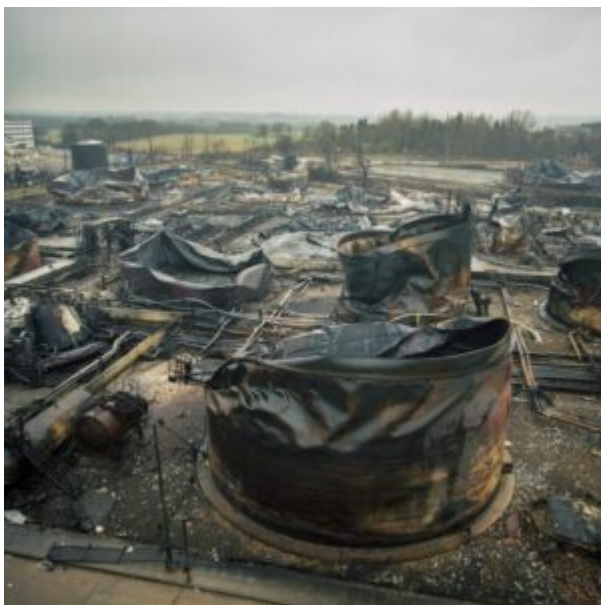
In the early hours of Sunday 11th December 2005 explosions occurred at Buncefield Oil Storage Depot, Hemel Hempstead, Hertfordshire.

In the early hours of 11 December 2005, a storage tank at the Buncefield oil storage depot overfilled, releasing a massive petrol vapour cloud that spread beyond the site perimeter and ignited. The resulting explosions and fires caused widespread damage and disruption, forcing thousands of residents and businesses to evacuate.

The investigation identified systematic failings in tank level monitoring, overfill prevention and safety management systems. Weak oversight and inadequate controls allowed large quantities of petrol to overflow undetected, leading to the release of a vapour cloud that ignited with catastrophic force.

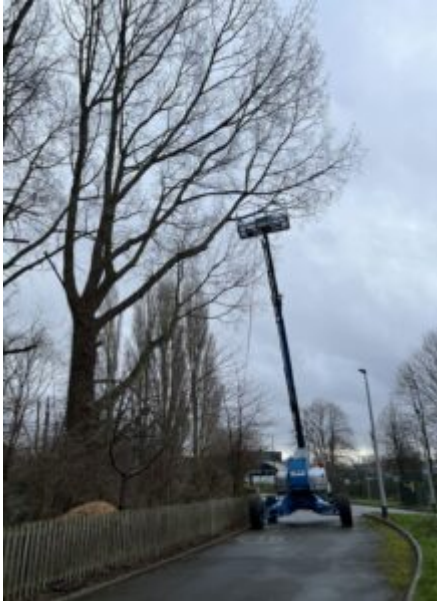
An employee of AP Tree Specialists Ltd had been carrying out tree surgery from the basket of a mobile elevating work platform (MEWP) at a mobile site in Derby on 25 January 2024. When the machine stopped working while elevated, there was no one on site who could bring the basket safely to the ground. The employee attempted to abseil from the basket, resulting in a fall to the ground.

The basket of a mobile elevating work platform (MEWP)

An investigation by the Health and Safety Executive found that AP Tree Specialists Ltd failed to plan, appropriately supervise and carry out work at height in a safe manner. The company had not completed a suitable and sufficient risk assessment for work at height activities, and employees were not appropriately trained in the use of lifting equipment.

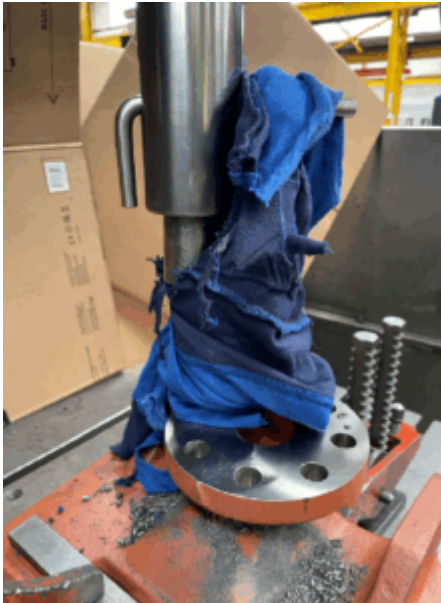
The radial-arm drill

An investigation by the Health and Safety Executive (HSE) found that Power and Energy International had failed to take appropriate measures to ensure the safety of their employees. The company's radial-arm drills did not have adequate guarding. Machine operators, including Harry, had not been properly trained on using the safety features. The company was also found to have made modifications to the radial-arm drill which increased the risk of operators getting caught and pulled into the machine.

HSE guidance states employers must properly assess risks and take effective measures to prevent access to dangerous parts of machinery. This is normally achieved with fixed or adjustable guards but where this is not practicable other protective devices may be needed that stop the movement of dangerous parts. Employers must also ensure that they provide their employees with the necessary level of information, instruction, training, and supervision to enable them to work safely with the equipment they use. Guidance on health and safety in engineering workshops can be found on the HSE website: [Health and safety in engineering workshops – HSE](#)

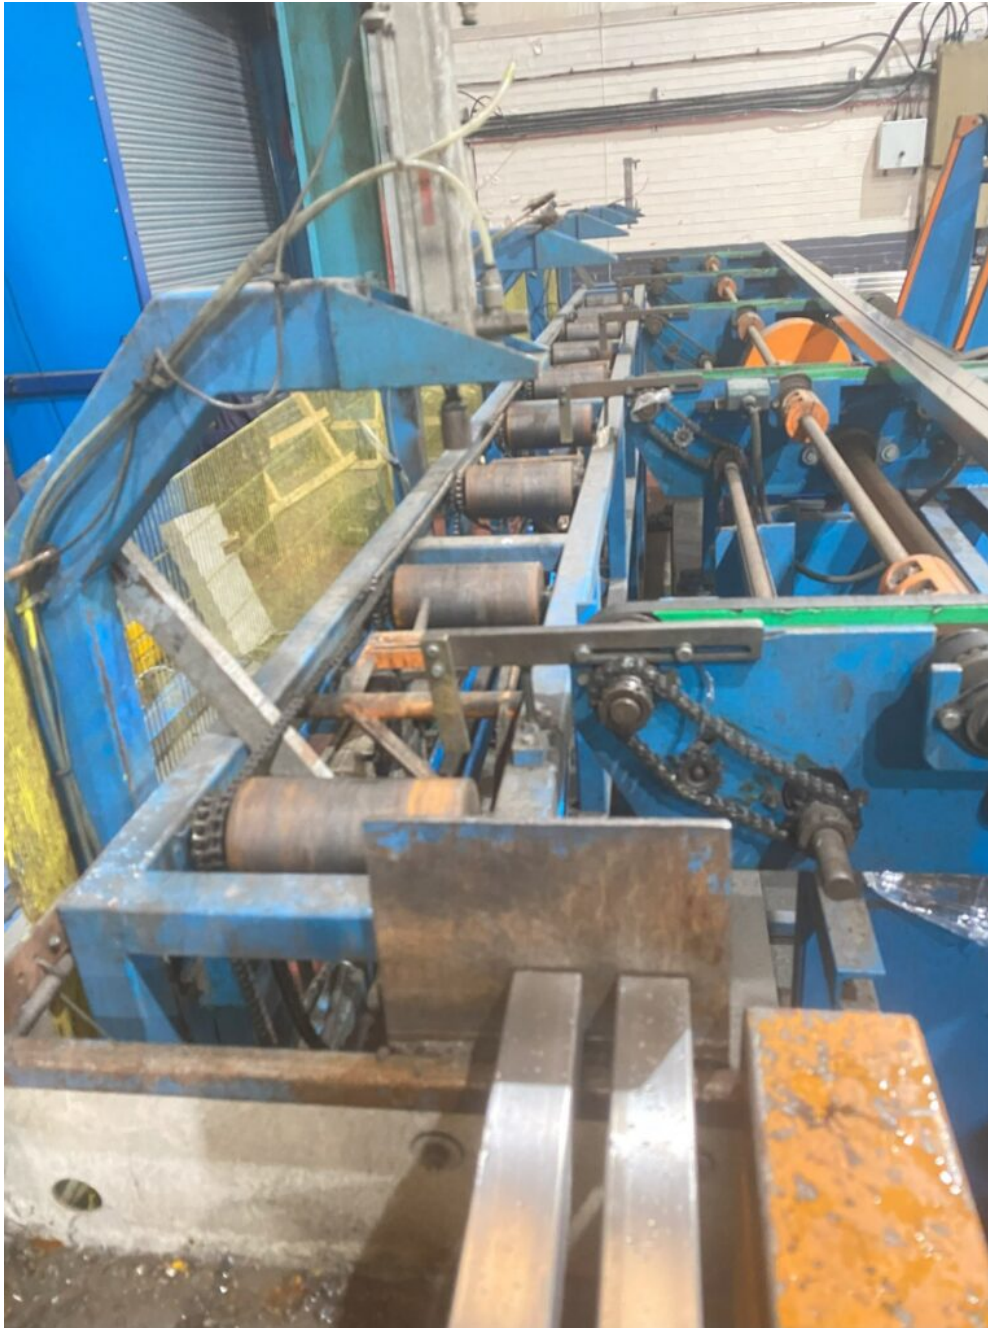
Nathan Watkins was working for FMP West Midlands Limited in Oldbury, West Midlands, on 8 July 2024, when he was loading a tube polishing machine. The machine had faulty rollers, which required Mr Watkins to lean over and straighten the metal tubes. As he did so, his left hand became entangled in the machine's unguarded cogs and chains.

An investigation by the Health and Safety Executive (HSE) found that FMP West Midlands Limited failed to prevent access to dangerous parts of machinery, namely the rotating cogs and chains on the rollers.

Tube polishing machine

HSE provides clear guidance under the Provision and Use of Work Equipment Regulations 1998 on preventing access to dangerous parts of machinery. The first consideration should be physically enclosing the dangerous part with fixed guards to prevent access, which should be securely attached and not easily removed. Further guidance can be found at HSE's website: [Safe use of work equipment. Provision and Use of Work Equipment Regulations 1998. Approved Code of Practice and guidance L22](#))

"The tube polishing machine was not up to safety standards. Had FMP West Midlands Limited installed suitable guarding, this life-changing injury would not have occurred.
