Edinburgh Airport fined after pensioner fell from ambulift

- James Young died in hospital more than a week after the fall
- Locking fault on “ambulift” had been in place for some time before incident
- HSE guidance is available on the maintenance of work equipment.

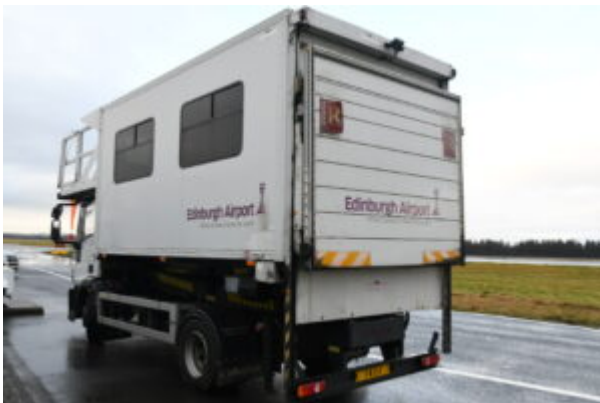
The Ambulift used by Mr Young and his wife

Passengers who cannot embark or disembark using the aircraft steps can use an ambulift cabin, which is capable of being elevated to the level of the aircraft’s door and lowered to the chassis of the vehicle. At the rear of the vehicle, a tail lift platform is then deployed to the same level as the floor level of the passenger compartment.

Passengers then exit the compartment onto the tail lift, which unlike the compartment, is not enclosed, but has safety side rails and a rear gate around its perimeter. Once secure on the tail lift, it is lowered to ground level, allowing its users to move on to the tarmac step free.

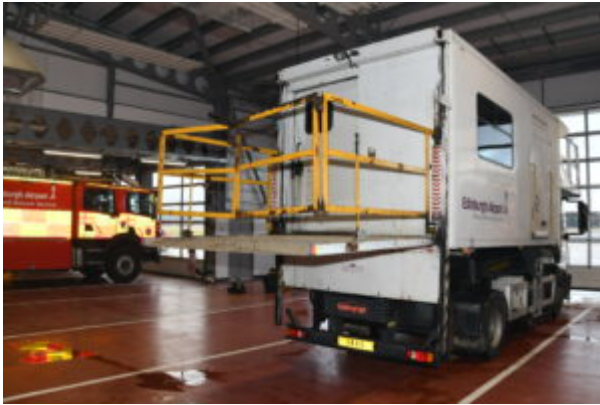
The locking mechanism on the safety rail was misaligned

As a result of the incident, Edinburgh Airport Limited submitted a [RIDDOR](#) to the Health and Safety Executive (HSE) and an investigation was carried out. That found that when it was raised from the ground, the locking mechanism on the tail lift's safety rail was misaligned, meaning it could potentially open outwards if pressure was applied to it. When the safety rail moved outwards from the lifting platform an open edge was created and it was through this that Mr Young fell.

The Provision and Use of Work Equipment Regulations 1998 require every employer to ensure that work equipment is maintained in an efficient state, in efficient working order and in good repair. Equipment must be maintained

“It is clear that the fault on the ambulift had been in place before Mr Young fell from the platform.

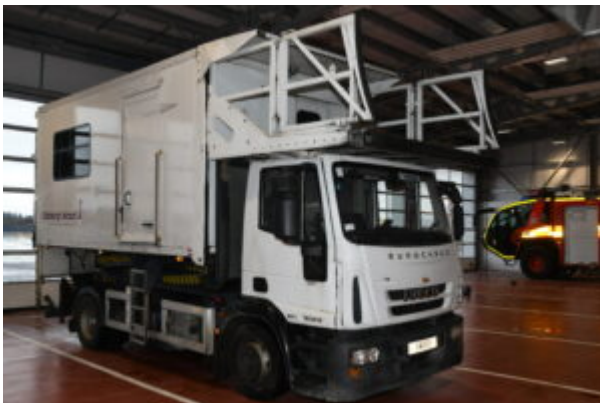
The ambulift that was used on the day in question

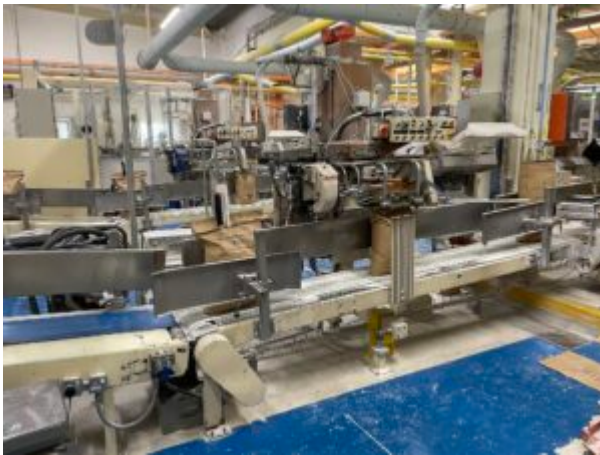
a packer closing station. However, the 800-kilogram machine became unbalanced and tipped backwards, trapping his left hand. This resulted in the little finger on the hand being severed.

A yellow brace was installed on the machine following the incident

The incident was investigated by the Health and Safety Executive (HSE) which found the company had failed to safely manage the risks of people performing maintenance at its factory.

ADM Milling Limited were required to fully assess the task that the injured person was assigned, to ensure that his health and safety was not put at risk.

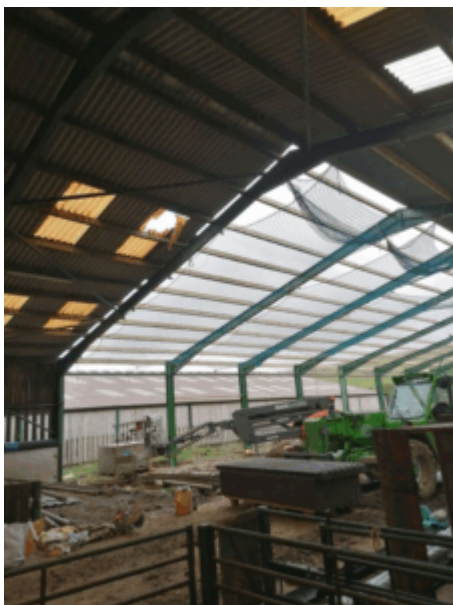
He was working for Norman Iveson Steel Products, as part of a project to extend the sheep barn. Roof sheets needed to be installed, bridging the gap between the old roof and new. Jack, from Bedale, was carrying out the work on 11 October 2022 when he stepped onto a fragile roof light which immediately broke under his weight. He fell from a height of around six metres.

Jack Croft fell through the barn roof light

An investigation by the Health and Safety Executive (HSE) found the company had failed to implement basic working at height control measures, such as safety netting, to prevent falls from height in this area. The netting that was in place on site did not cover full work areas and was installed by persons without the sufficient skills to rig it. HSE also found a failure to plan, manage and monitor the construction phase, to ensure it was carried out in a safe manner.
