Edinburgh Airport fined after pensioner fell from ambulift

- James Young died in hospital more than a week after the fall
- Locking fault on “ambulift” had been in place for some time before incident
- HSE guidance is available on the maintenance of work equipment.

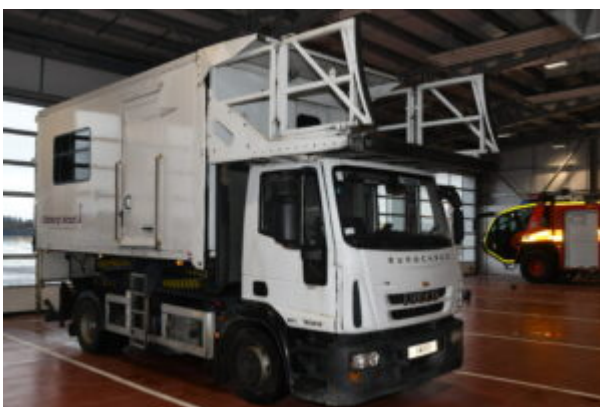
Passengers then exit the compartment onto the tail lift, which unlike the compartment, is not enclosed, but has safety side rails and a rear gate around its perimeter. Once secure on the tail lift, it is lowered to ground level, allowing its users to move on to the tarmac step free.

Mr Young attempted to pass a piece of hand luggage to a worker on the ground whilst the tail lift had not yet been lowered. It is believed he leant against the safety rail, which swung open causing him to fall approximately five feet to the ground below.

The ambulift that was used on the day in question
