Press release: Improving efficiency at mine water treatment schemes

The Coal Authority, which manages Britain's coal mining legacy, employs contractors to clean water cascades and pipework across its 75 mine water treatment sites on a regular basis.

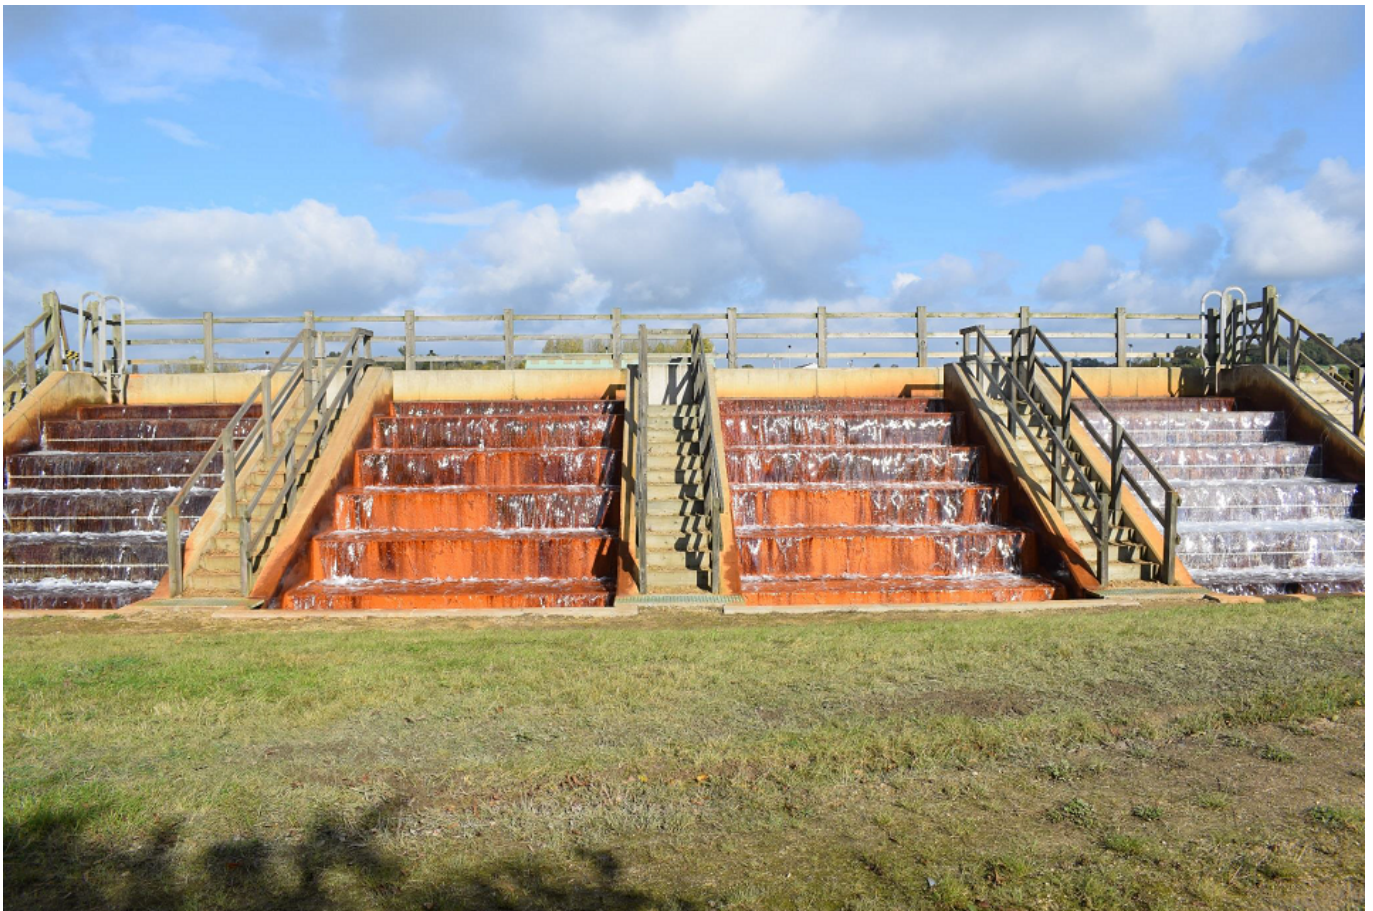
At the treatment scheme located at the site of the former Blackwell A Winning pit at South Normanton, there are 4 water cascades. For the trial, one was fully cleaned and coated for testing, a second has also been cleaned to act as a control and the remaining 2 are continuing under the current maintenance regime for comparison.

The 4 water cascades at the mine water treatment scheme

Further testing and studies will also be carried out on a series of concrete slabs installed in the cascades. One sample will be retrieved every week for the first month followed by monthly sampling for the remainder of the 6 month trial.
