Global glass bottle maker fined £600k after worker injured

- Man suffered burns after molten glass was spilled.
- Protective door missing from shovel loader for two years.
- HSE guidance is available:

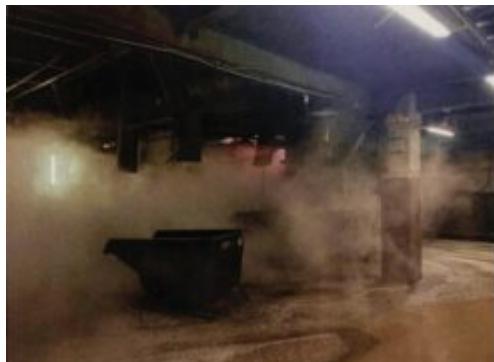
The basement of the site and the skips being used to collect waste product

The company, which employs around 500 people at the site, continually operates furnaces that are used to smelt raw materials, from which glass bottles are manufactured. The furnaces and production lines are located on the floor above two glass reject basements, which house a number of large, moveable skips. It is into these skips that molten or formed glass is rejected, via chutes, during the production process. Coolant water runs down each chute with the rejected molten or formed glass, which in turn generates very hot water and large amounts of steam.

Due to the continuous nature of the operation, the skips would quickly fill and sometimes reject material and water would spill from the skips onto the basement floors. Employees working in these basements used shovel loaders to clear this spilled material from the floors, which was then emptied into other skips.

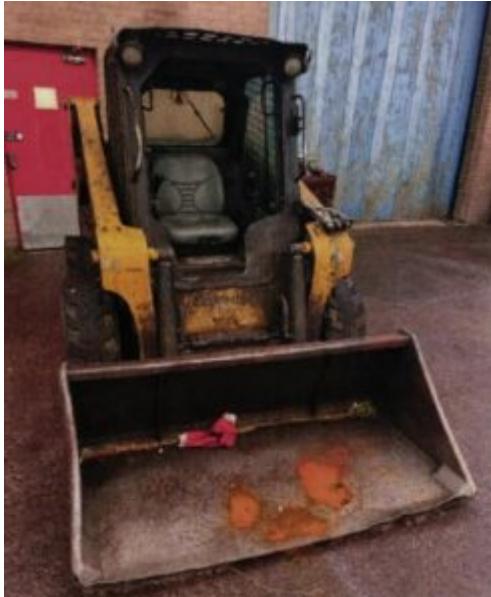
On the day in question, the worker had been operating a shovel loader, clearing the waste molten glass and hot water from the basement floor. However, there was no protective door on the cab of the vehicle, so some of that material spilled from the bucket onto him.

The shovel loader with missing protective door

When it was first provided for use, the loader was fitted with a protective door incorporating a glass window, in front of the cab. However, an investigation by the Health and Safety Executive (HSE) established that the protective door had been missing since March 2022. It had been removed from the vehicle after being damaged, and although this was reported to the site engineer at the time, no action was taken to replace it. In the almost two years that went by, other operatives had reported being struck or having footwear burnt by molten glass falling into the cab.

“This company’s employees worked in this environment with a safety critical part of the loader missing for a period of almost two years.

“Although the protective front door had been removed and reported to the on-site engineer, drivers had continued to work and operate the loader with it missing.

“When work equipment is being selected, its suitability for the environment it is going to be used in must be risk assessed. In this case the protective door was not suitable to protect against impacts from hot and molten glass and therefore was often broken and in the end never replaced. Had an appropriate door been selected and maintained in place this accident would not have occurred.”

Following the incident, the company removed the vehicle from service, and it didn't return until June 2024, after being fitted with a steel front door, incorporating a glass window with protective wire mesh.
