# Metal gate manufacturer fined after exposing workers to serious safety risks

## **Taylor Wimpey fined £800,000 after teen apprentice injured on site**

# Edinburgh Airport fined after pensioner fell from ambulift

## **Cheshire college fined after student's fingers severed**

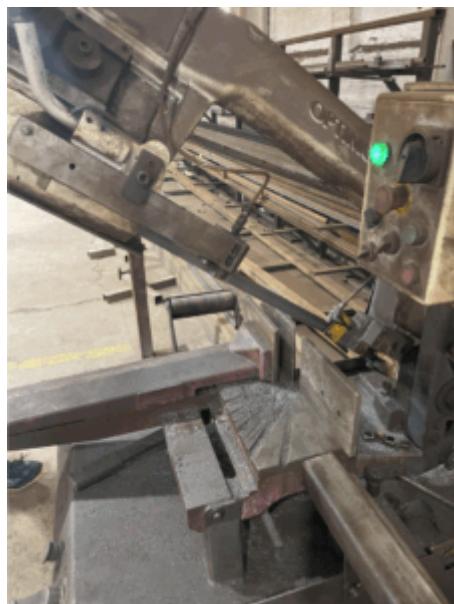
Buzzsaw without guard

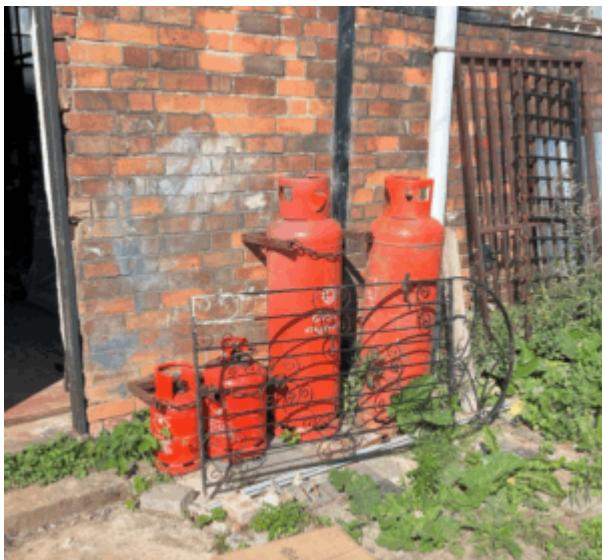
Unsafe storage of flammable gas

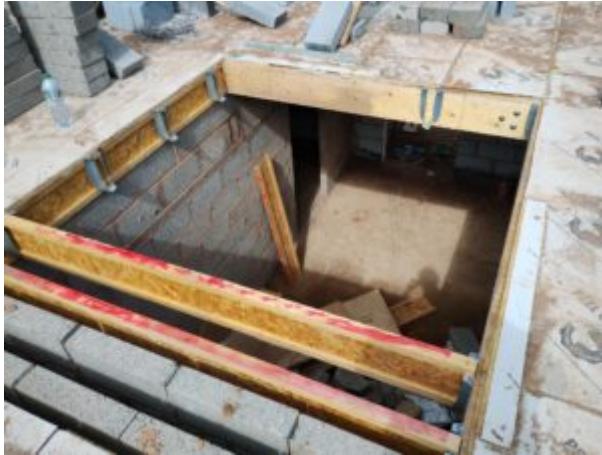
The collapsed stairwell after the incident

On 22 August 2023 Charlie had been loading concrete blocks onto the temporary flooring on the first floor of one of the newly built homes. The blocks were being loaded into stacks of between 10 and 20, one of which was on or near to a temporary stairwell covering. This was a large area covered with a timber sheet material laid over joists – both of which would be later removed to install the staircase.

However, the area collapsed, causing Charlie and around 20kg of the concrete blocks to fall more than two metres to the ground below. He sustained injuries to his fingers, hand, wrist and shoulder.

The subsequent HSE investigation found that the joists under the timber sheet material should have been back propped. This was mentioned a number of times in Taylor Wimpey's own health and safety manual for the site, however, it had been missed on this particular plot. Had suitably designed back propping been used, it is unlikely the incident would have occurred.

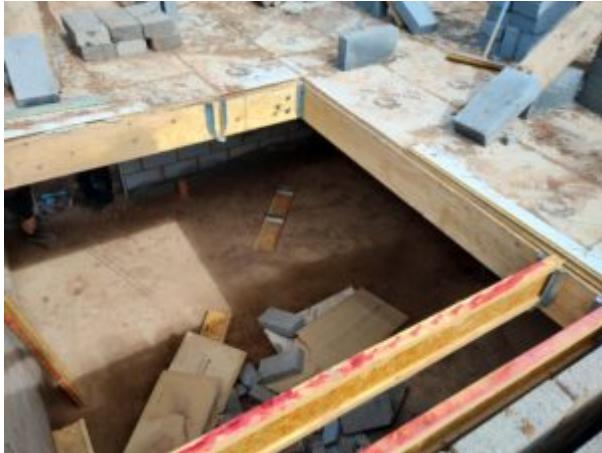
Charlie Marsh, who was 17 at the time, fell through the stairwell with between 10 and 20 concrete blocks

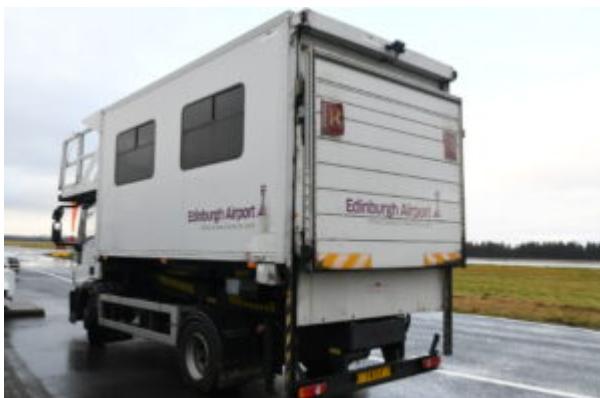
The Ambulift used by Mr Young and his wife

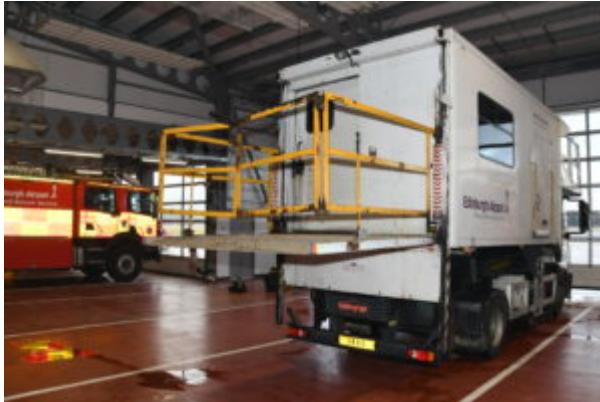
The locking mechanism on the safety rail was misaligned

Mr Young attempted to pass a piece of hand luggage to a worker on the ground whilst the tail lift had not yet been lowered. It is believed he leant against the safety rail, which swung open causing him to fall approximately five feet to the ground below.

As a result of the incident, Edinburgh Airport Limited submitted a [RIDDOR](#) to the Health and Safety Executive (HSE) and an investigation was carried out. That found that when it was raised from the ground, the locking mechanism on the tail lift's safety rail was misaligned, meaning it could potentially open outwards if pressure was applied to it. When the safety rail moved outwards from the lifting platform an open edge was created and it was through this that Mr Young fell.

The Provision and Use of Work Equipment Regulations 1998 require every employer to ensure that work equipment is maintained in an efficient state, in efficient working order and in good repair. Equipment must be maintained

so that its performance does not deteriorate to the extent that people are put at risk. [HSE guidance](#) is available on the maintenance of work equipment.

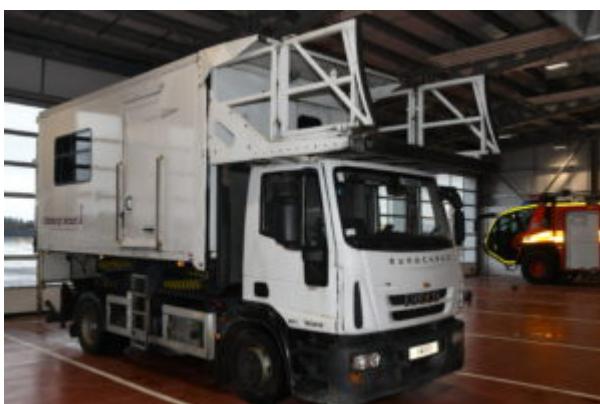
The ambulift that was used on the day in question
