Manufacturer sentenced after a sawmill worker lost his leg following an accident at work

A large wood manufacturer in Shropshire has been fined £160,000 after an employee sustained life-changing injuries when working at their Ellesmere premises.

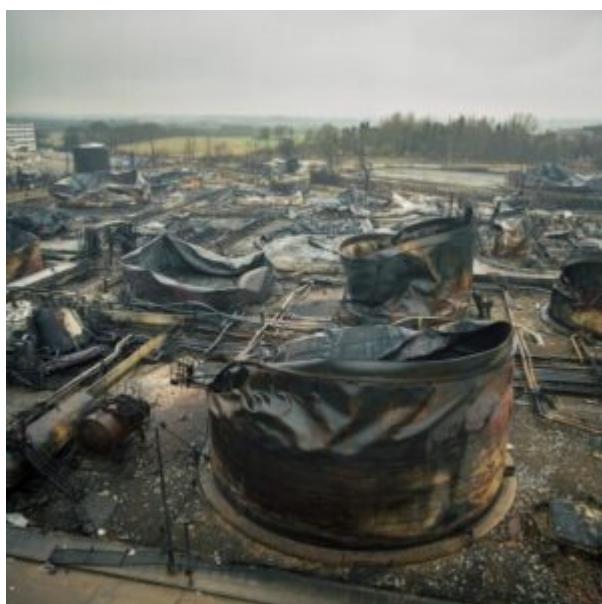
In the early hours of Sunday 11th December 2005 explosions occurred at Buncefield Oil Storage Depot, Hemel Hempstead, Hertfordshire.

In the early hours of 11 December 2005, a storage tank at the Buncefield oil storage depot overfilled, releasing a massive petrol vapour cloud that spread beyond the site perimeter and ignited. The resulting explosions and fires caused widespread damage and disruption, forcing thousands of residents and businesses to evacuate.

The investigation identified systematic failings in tank level monitoring, overfill prevention and safety management systems. Weak oversight and inadequate controls allowed large quantities of petrol to overflow undetected, leading to the release of a vapour cloud that ignited with catastrophic force.

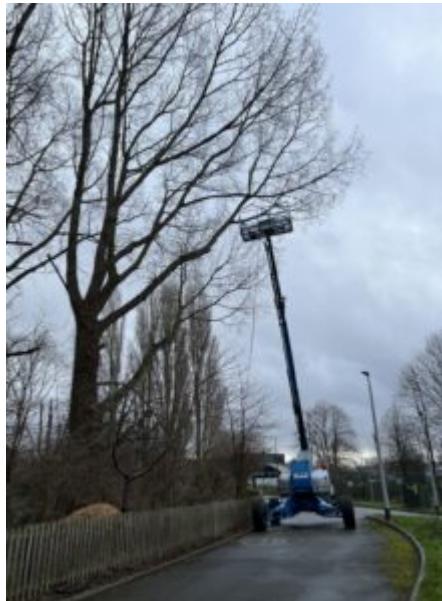
An employee of AP Tree Specialists Ltd had been carrying out tree surgery from the basket of a mobile elevating work platform (MEWP) at a mobile site in Derby on 25 January 2024. When the machine stopped working while elevated, there was no one on site who could bring the basket safely to the ground. The employee attempted to abseil from the basket, resulting in a fall to the ground.

The basket of a mobile elevating work platform (MEWP)

An investigation by the Health and Safety Executive found that AP Tree Specialists Ltd failed to plan, appropriately supervise and carry out work at height in a safe manner. The company had not completed a suitable and sufficient risk assessment for work at height activities, and employees were not appropriately trained in the use of lifting equipment.

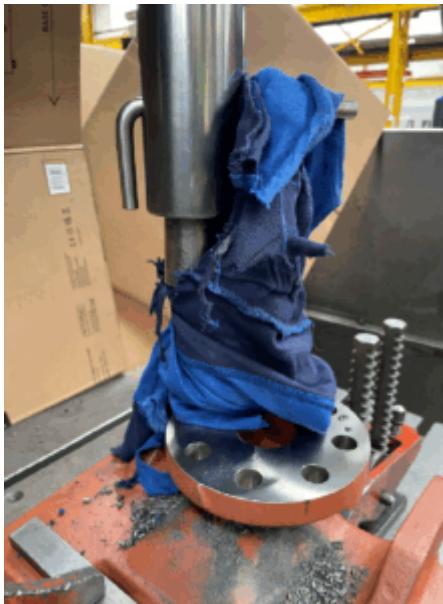
The radial-arm drill

An investigation by the Health and Safety Executive (HSE) found that Power and Energy International had failed to take appropriate measures to ensure the safety of their employees. The company's radial-arm drills did not have adequate guarding. Machine operators, including Harry, had not been properly trained on using the safety features. The company was also found to have made modifications to the radial-arm drill which increased the risk of operators getting caught and pulled into the machine.

HSE guidance states employers must properly assess risks and take effective measures to prevent access to dangerous parts of machinery. This is normally achieved with fixed or adjustable guards but where this is not practicable other protective devices may be needed that stop the movement of dangerous parts. Employers must also ensure that they provide their employees with the necessary level of information, instruction, training, and supervision to enable them to work safely with the equipment they use. Guidance on health and safety in engineering workshops can be found on the HSE website: [Health and safety in engineering workshops – HSE](#)
