Mining company fined after electrician killed at Europe's only underground quartz sand mine

The operator of Europe's only quartz sand mine has been fined after an experienced electrician was killed after being struck by the blades of a mine BORA fan.

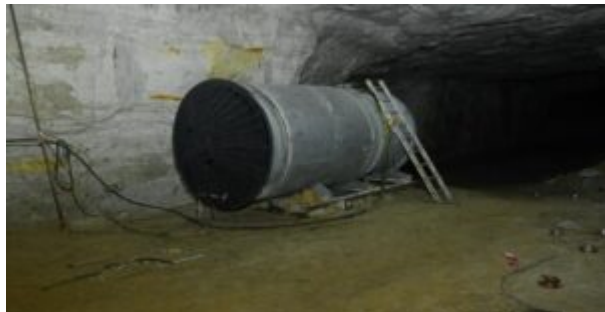
The sister fan of the one involved in the incident – the two had originally been together as one unit

The fan involved had originally formed part of a single in-line assembly unit with a sister fan. In June 2020, the decision was taken at the mine to split this single unit into two separate fans. HSE investigators found that the hazards arising from this modification had not been properly identified or managed. No written risk assessment was produced, no commissioning documents were created, and no records of any management discussion about the separation could be provided.

Critically, the splitting of the unit left the rotating parts of the Number 2 fan significantly closer to its intake guard than was safe. The fan blades were just 43mm – less than two inches – from the leading edge of the duct. The relevant guarding standard required a distance of at least 200mm, which could have been achieved through appropriate nose cone or cage-type guarding.

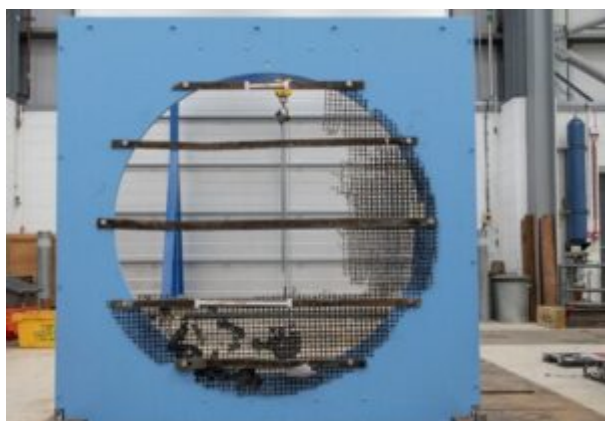
When inspectors examined the fan the day after the incident, the intake guard was found to be in a seriously degraded condition. Significant areas of mesh were missing, particularly around the fan's impeller hub. Wire and mesh pieces recovered from the floor showed heavy corrosion on their broken ends, indicating they had been in that condition for some time – not freshly broken during the incident. Further pieces of mesh had been ejected through the fan during the incident itself. Had the guard been properly designed and maintained, it is likely it would have prevented the fatal incident.

Significant areas of mesh were missing, particularly around the fan's

impeller hub

To cover the exposed intake, guards were fabricated on-site from two sheets of metal square lattice mesh, which HSE inspectors determined was poorly designed. The metal bracing straps were fitted on the outside of the mesh panels rather than the inside, providing no additional structural strength. The exhaust end of the fan remained entirely unguarded.

Compounding these failures, the two fans had not been listed on the mine's Mechanical Asset Register. No inspection checklists or maintenance records for them could be provided. While electrical inspections had been recorded, the degraded condition of the inlet guard had not been identified during those processes.

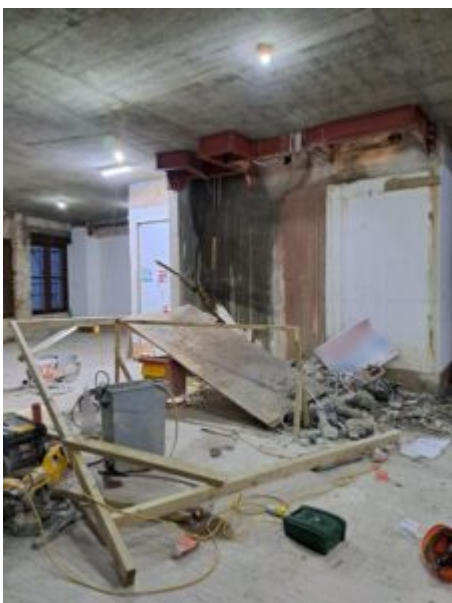
A temporary platform loaded with concrete debris collapsed on top of Steve Zschoch

Roots Contractors Ltd had instructed its carpenters to build temporary wooden platforms under each opening to collect the 16kg concrete cores and debris that were generated by the cutting.

Mr Zschoch had been cutting an opening on the third floor, working directly under one of the temporary platforms, when it suddenly gave way and collapsed on top of him, along with chunks of concrete that had not been cleared away.

An investigation by the Health and Safety Executive (HSE) found that there was no design for the temporary platforms and no calculation had been made for the safe level of loading.

Temporary works must be carefully managed. The law says any temporary structure must be designed, installed and maintained to withstand any foreseeable loads which may be imposed on it and that it be only used for the purposes for which it was designed, installed and maintained. They should be inspected by a competent person on a regular basis. Guidance on temporary works is available at [hse.gov.uk](https://www.hse.gov.uk).
