Global glass bottle maker fined £600k after worker injured

- Man suffered burns after molten glass was spilled.
- Protective door missing from shovel loader for two years.
- HSE guidance is available:

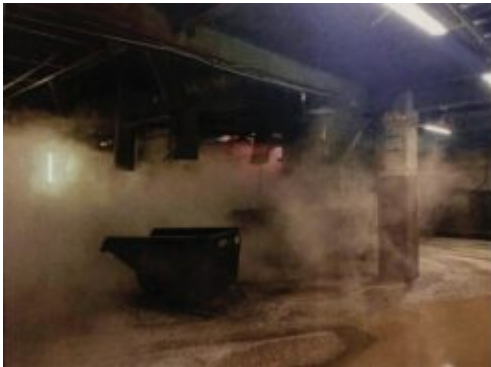
The basement of the site and the skips being used to collect waste product

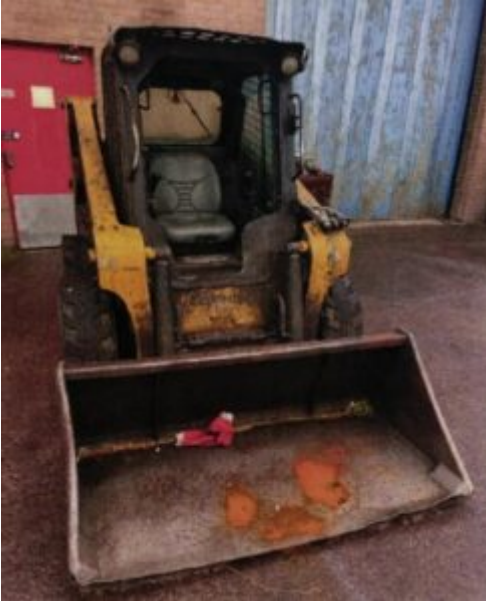
The shovel loader with missing protective door

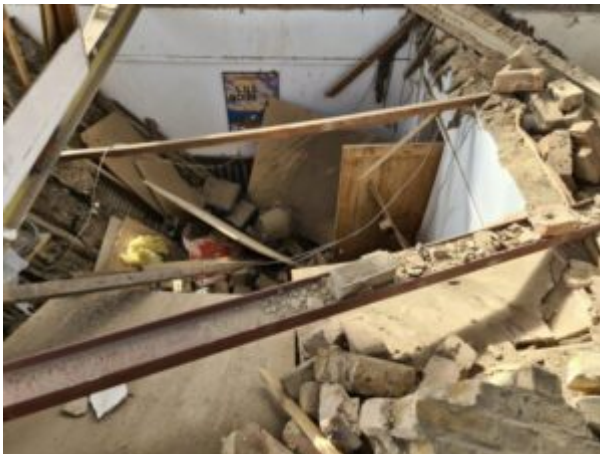
The homeowner was left with a £200k bill to rebuild their home

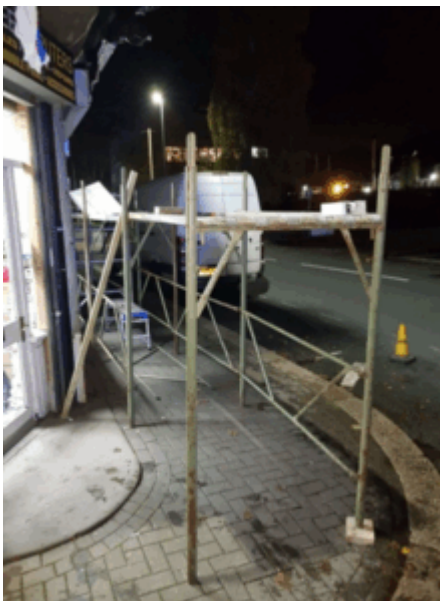
The scaffolding tower without edge protection

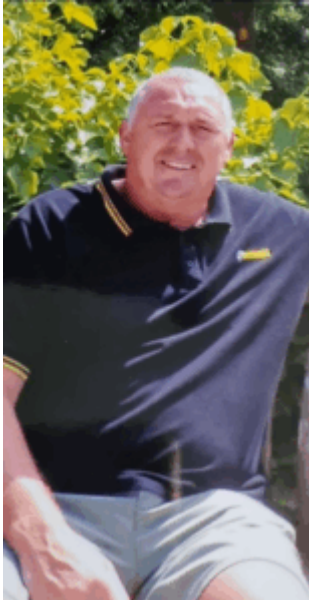
Gary Anstey, 57, from Bristol, was working for H. Mealing & Sons Limited at a construction site at a school in Bath when the incident happened on 19 March 2019.

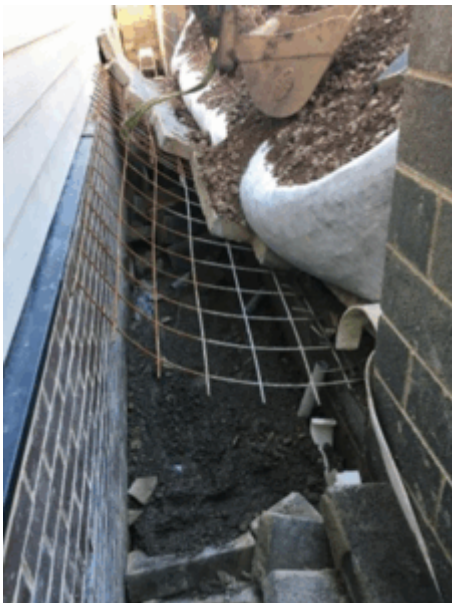
An investigation by the Health Safety Executive (HSE) found that H. Mealing & Sons Limited failed to properly plan and supervise the construction of the retaining wall at Swainswick School. This led to it becoming unstable when a large load of aggregate was placed against the incomplete wall which was not supported.
