Offshore firm fined following death of worker on Valaris 121 whose body was never recovered

An offshore firm has been handed a £267,000 fine after a long-running HSE investigation found that crewman Jason Thomas was killed when he fell through a missing deck grate and was lost to the North Sea.

EnSCO Offshore UK Limited (EO UK Ltd) was responsible for the operation of the Valaris 121 installation when the incident occurred on 22 January 2023.

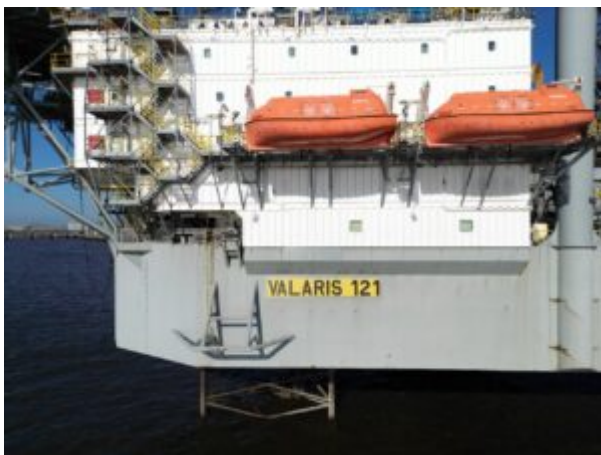
The incident aboard Valaris 121 when it was under tow
