Packaging company fined after worker suffers life-changing head injuries

A manufacturer of paper packaging has been fined after a worker suffered a severe skull fracture and permanent injuries when a 4.5-ton machine fell on him.

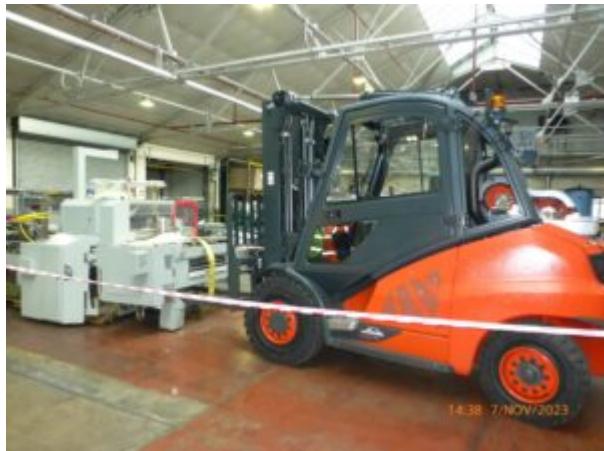
Mr King was part of a team relocating the machine from a warehouse to a storage area approximately 160 metres away. The machine, which weighed approximately 4.5 tons and measured 1.56 by 4.15 metres, had no lifting or anchoring points.

Image from scene

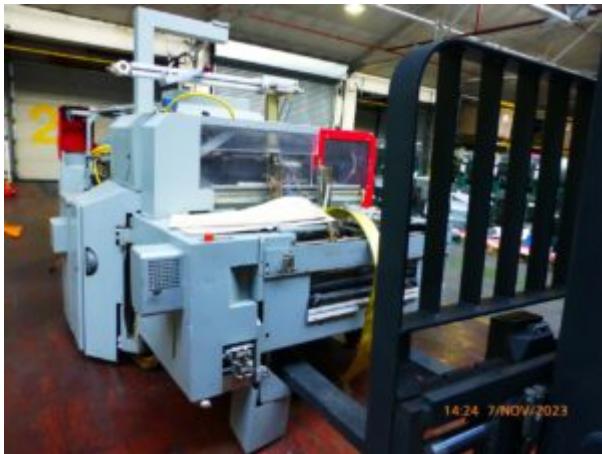
Workers had improvised a system involving lifting the machine with a forklift, placing skates underneath, and pulling it forward. The machine had already slid off the forks on at least two occasions before the incident.

At the time of the accident, Mr King was positioned underneath the suspended machine to secure a wheel on its underside when it slid from the forks and struck him on the head.

Image from scene

An investigation by the Health and Safety Executive (HSE) found that the lifting operation had not been properly planned by a competent person. The characteristics of the load, including its weight, size, centre of gravity and lifting points, had not been adequately assessed, and no safe system of work had been put in place.

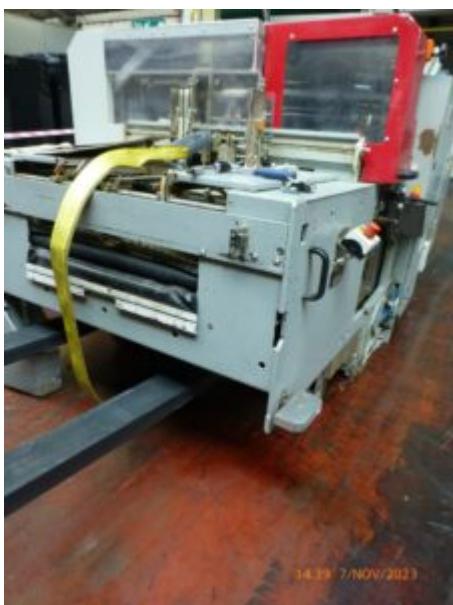
Image from scene
