Call for Evidence to Review Lifting and Pressure Systems Regulations

- Review aims to simplify regulatory processes whilst maintaining workplace safety standards

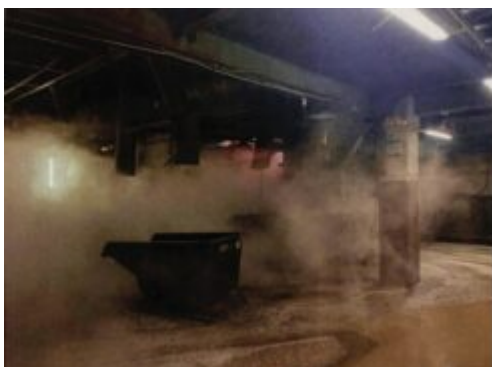
The basement of the site and the skips being used to collect waste product

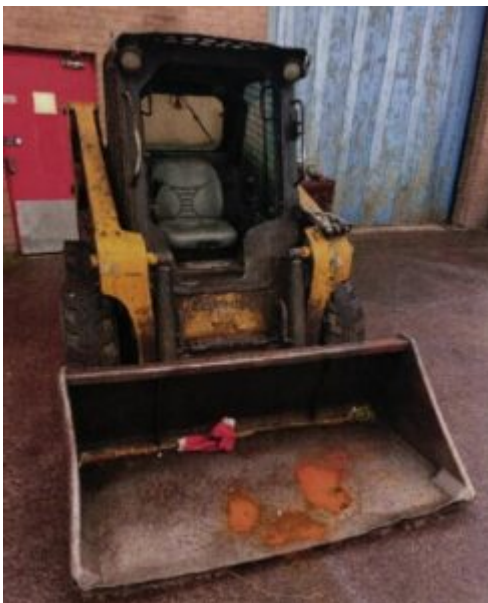
The shovel loader with missing protective door

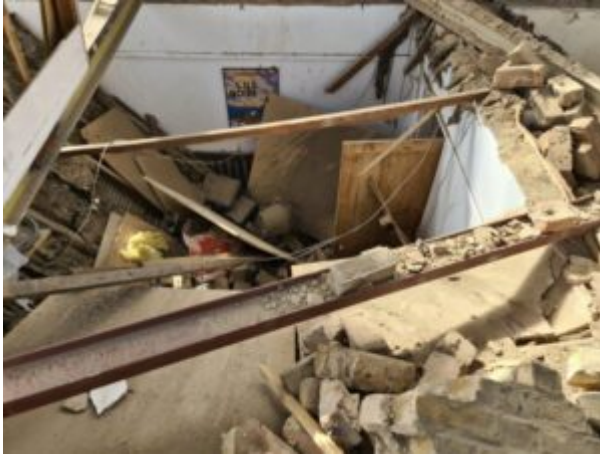
The homeowner was left with a £200k bill to rebuild their home

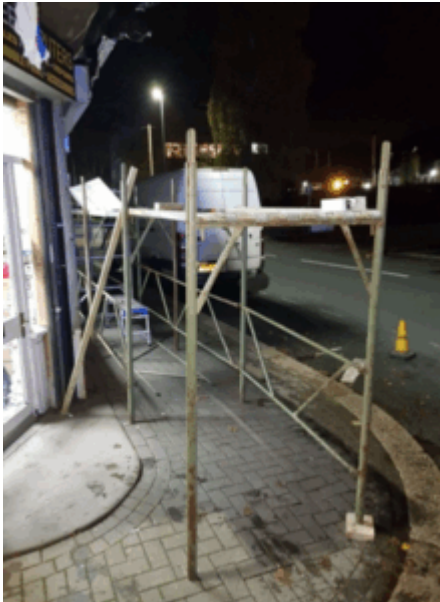
The scaffolding tower without edge protection
