# Two firms fined after worker fractures neck during platform collapse

- Temporary wooden platforms collapsed during refurbishment project in City of London
- Steve Zschoch, 60, described being 'folded up like a concertina' and has not been able to work since.
- HSE guidance is clear temporary structures must be designed, installed and maintained to withstand any foreseeable loads.

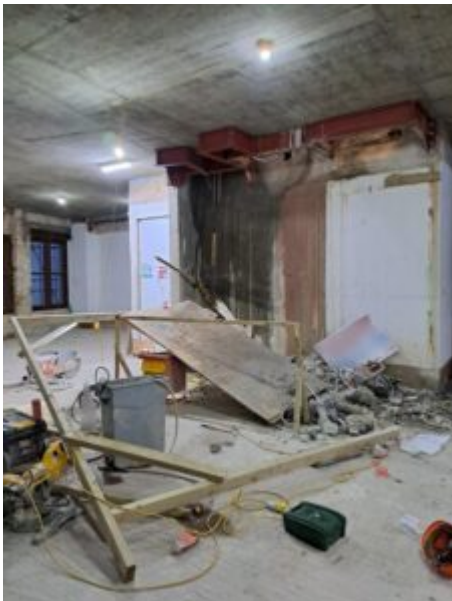
A temporary platform loaded with concrete debris collapsed on top of Steve Zschoch

An investigation by the Health and Safety Executive (HSE) found that there was no design for the temporary platforms and no calculation had been made for the safe level of loading.

While an inspection form for the platform was completed, it failed to identify any issues with the design, and the person tasked to complete it was not a competent temporary works coordinator. We also found that although there had been a verbal instruction for workers to regularly clear the platforms of concrete and not 'overload' them, no safe level of loading was known, and there was no monitoring of whether the platforms were indeed cleared.
