Sign fitting company and director fined after fatal fall from scaffolding

[Building firm fined after employee killed by collapsing wall in Bath](#)

Construction company fined after child injured by falling cast iron soil pipe

Company fined after worker run over by forklift truck

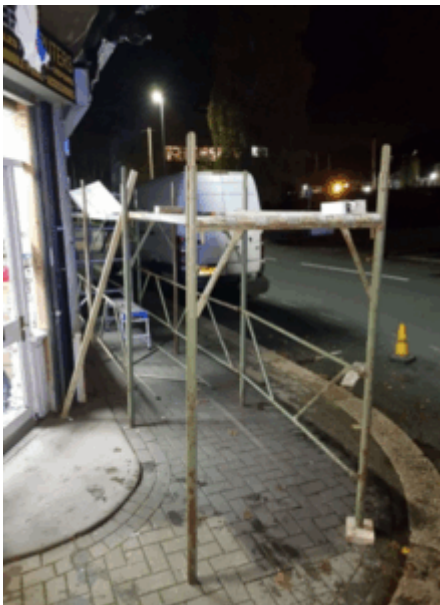
Mr Mughal, 64, was working for WH Metals Limited installing a metal sign to the front of the shop in Darwen, Lancashire. He was standing on the platform of a scaffolding tower without any edge protection in place, when he fell to the pavement below.

Although the height he fell from was only six feet, it was enough for him to suffer serious head injuries which resulted in him being taken to hospital by ambulance. Sadly, he died from his injuries four days later.

The scaffolding tower without edge protection

An investigation by the Health and Safety Executive (HSE) found that WH Metals Limited and its director, who was on site at the time of the incident, failed to prevent the risk of a fall from a distance liable to cause personal injury.

HSE guidance on working at height is available on the HSE website: [Work at height – HSE](#). The preferred method of fall prevention on tower scaffolds is

the fitting of suitable guardrails around the platform. This is a well-known and long-established control measure. If this had been in place at the time of the incident, it is highly unlikely that the worker in this case would have died.

"This incident highlights the importance of suitable control measures, such as edge protection, to minimise the risk of serious personal injury."

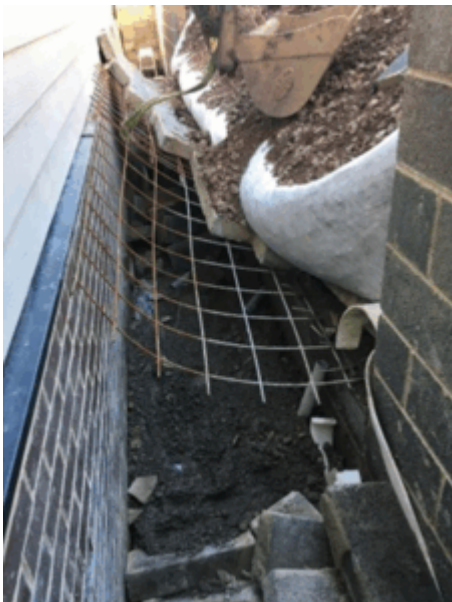
A building company has been fined after an employee was crushed to death when a 1.8m high retaining wall collapsed onto him.

An investigation by the Health Safety Executive (HSE) found that H. Mealing & Sons Limited failed to properly plan and supervise the construction of the retaining wall at Swainswick School. This led to it becoming unstable when a large load of aggregate was placed against the incomplete wall which was not supported.

Collapsed wall

HSE guidance [Temporary Works – HSE](#) requires that any temporary structure must be designed and installed to withstand any loads placed against it and that it is used in accordance with its design. This includes ensuring appropriately trained operatives are provided with a suitable written design and plan to install to ensure the structure remains stable.

"It happened because of a lack of planning and coordination, which is all too common in construction activity. With simple clear procedures and appropriate training this incident would not have happened."

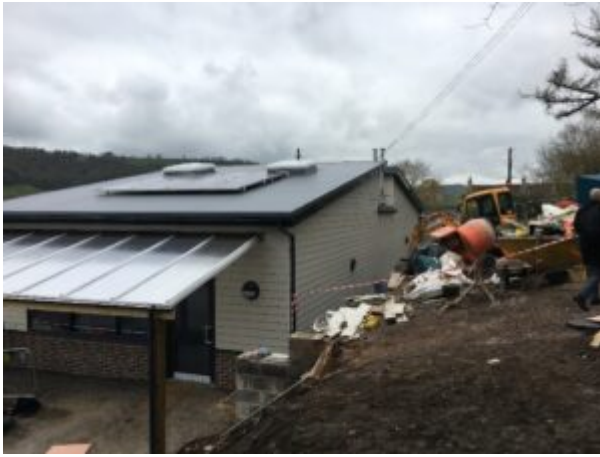
Aggregate at the construction site in Bath

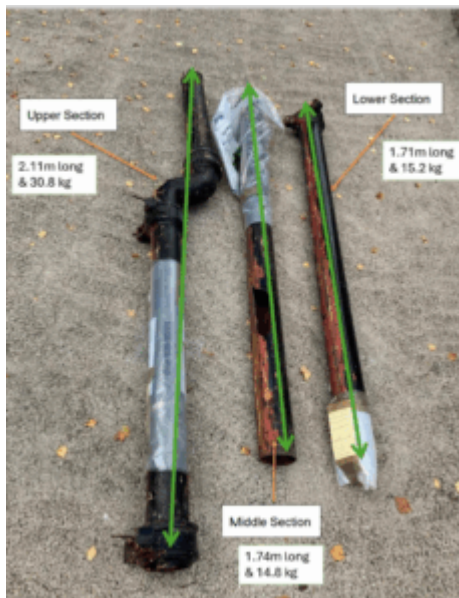
The incident occurred on 20 July 2021, during building work on an extension to a house in Totton – a few seconds' walk from a local primary school. A cast iron pipe fell onto a passing child striking him on the head and fracturing his skull.

The base of the pipe had been broken away by the builder some days before to allow him to excavate into the concrete floor. When a TV cable was freed from the pipe, the top two sections of pipe, weighing over 45kg, fell across the pavement. The cast iron pipe was estimated to date from the 1930s, and both the pipe and the fixings were corroded.

The cast iron soil pipe

An investigation by the Health and Safety Executive (HSE) found that Sage Homes Limited and its director, Jason Scorey, had failed to properly assess what was a foreseeable risk. In giving evidence, Mr Scorey insisted that he

could see no need to secure the pipe against the wall.

"It would have been a simple and inexpensive task to secure the pipe once it had been broken out at its base. The fact that the construction work was being carried out yards from a school gate at the time parents were collecting their children should have prompted even more care on the part of the duty holder.

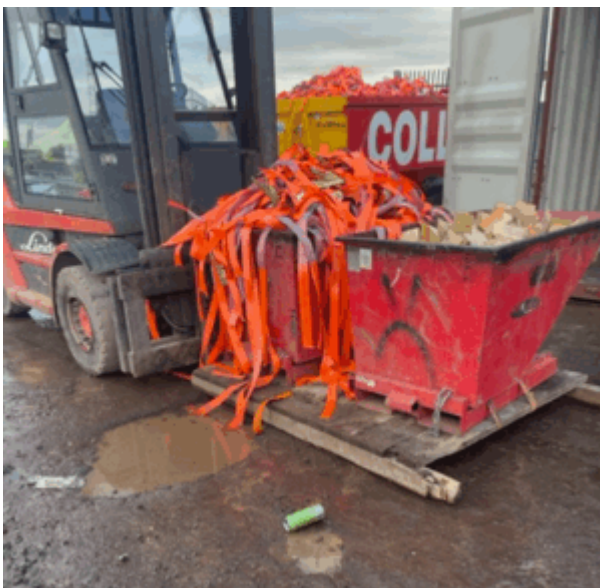
The two tipping bins had been positioned on a pallet, which was being carried on the forks of the forklift truck.

The forklift truck involved in the incident with two bins on a pallet

The 21-year-old was standing on the pallet and as the forklift truck moved some of the straps fell from the full waste bins, trailing on the floor and getting caught in the wheels of the lift truck. One of these straps got caught on his foot pulling him to the ground and the forklift truck drove over his foot.

An investigation by HSE identified that Qube Containers Limited failed to provide equipment that was safe and suitable for the task and failed to risk assess the system of work for emptying the bins – which was found to be

In addition, the traffic routes were not organised in a safe manner, and it was clear from the work practices on site that vehicles and pedestrians circulated in close proximity.

HSE Inspector Adepeju Sogadgi said: "This injury could easily have been prevented. Employers introducing new processes should make sure they assess the work activity sufficiently and apply effective control measures to minimise the risk. There should be systems in place to ensure safety and the risk should have been considered and documented."
