# Company fined £350,000 after chemical tank collapse left worker with life-changing injuries

- 700-tonne tank containing calcium chloride was more than 30 years old and corrosion was first identified a decade before incident.
- 62-year-old left with life-changing injuries and not been able to work since.
- Peterhead base handles thousands of ship movements each year.

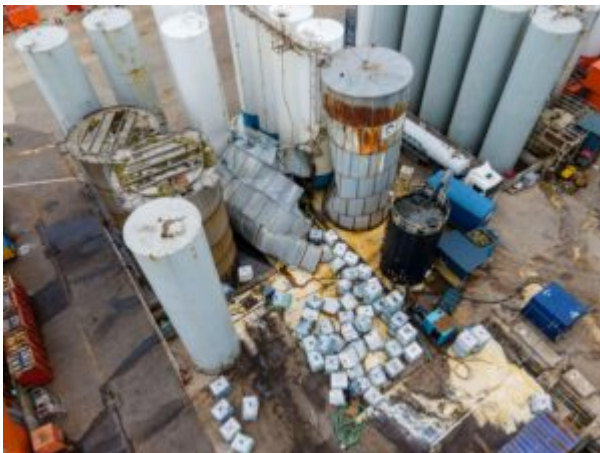
A still of drone footage captures the aftermath

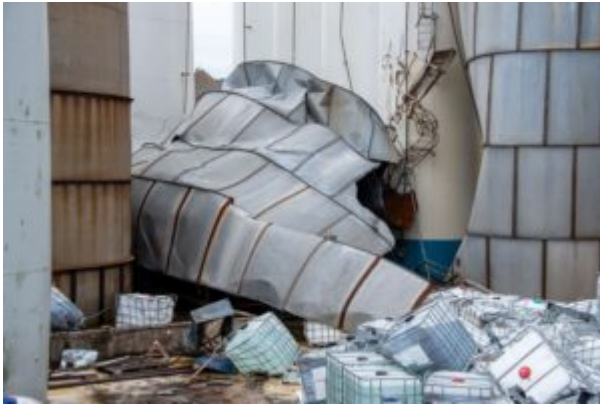
The 700-tonne tank was more than 30 years old

HSE's investigation, conducted by both regulatory and specialist inspectors, identified that the structural failure occurred around halfway up the tank shell, where the third row of plates split vertically along a bolted seam. Approximately 4.5mm of the original 5.5mm steel plate had been lost through corrosion over time, leaving just 1mm of steel unable to withstand the outward forces of the fluid within. Investigators found that the loss of any protective coating had left the steel surfaces exposed to aggressive coastal air, accelerating external degradation. The density of calcium chloride – more than one third denser than water – further increased the forces applied to the already weakened structure.

The tank was more than 30 years old and the manufacturer's maintenance manual required six-monthly checks of seams and bolts, and annual external inspections for corrosion. An inspection in 2013 had already identified extensive outer surface corrosion over the lower section of the tank and corrosion at bolted connections, yet no remedial work was carried out on Tank

Following the incident, the company removed all bolted tanks from its sites and closed its Peterhead operation, relocating to its Aberdeen premises.

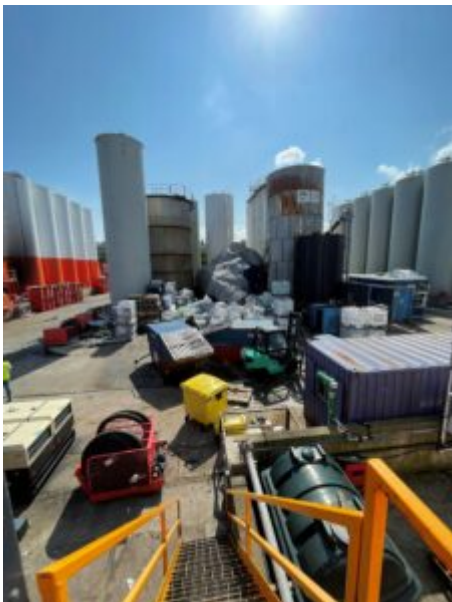
HSE inspectors arrived on site and took this photo of the scene
