# Company fined after worker became entangled on a manual lathe

An engineering company, has been fined for safety breaches after an employee suffered serious injuries to his left arm and hand whilst operating a manual lathe.

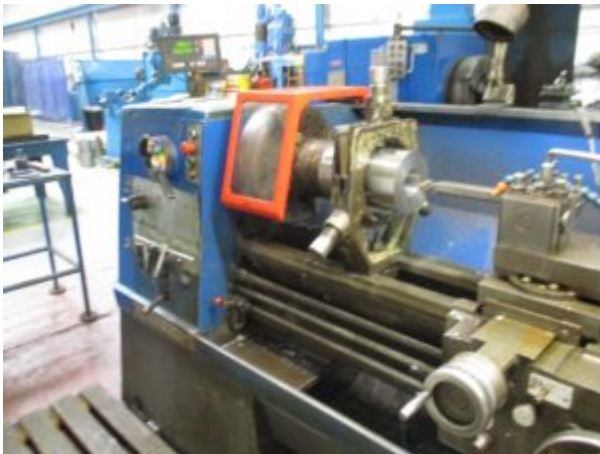
Sheffield Magistrates' Court heard that, on 26 February 2018, a 61-year-old worker of Wincobank Fabrication and Engineering Ltd (WFE) was polishing a solid chrome bar on the lathe using hand-held emery cloth when his left hand and arm became entangled with the rotating bar on the company site on Sheffield Road, Rotherham. As a result, his left index and middle fingers were amputated and his wrist and two bones in his left forearm were broken. The worker required surgery and metal plates were inserted into his arm.

An investigation by the Health and Safety Executive (HSE) found that the hand application of emery cloth on manual lathes was custom and practice amongst lathe operators at WFE. The risk assessment in place for the machine had not considered the risks from polishing, or identified suitable control measures for operation of the lathe. At the time of the incident, the injured party had been employed at WFE for just under one month and had not received adequate instruction and training on how to polish safely. The investigation also found that he was wearing gloves at the time of the incident which significantly increases the risk of entanglement. HSE guidance clearly states that hand polishing on a manual lathe with emery cloth is strictly prohibited.

“Such accidents could easily be avoided by properly assessing the risks to determine whether the use of emery cloth on these machines can be eliminated completely. Where this is not practicable, then a safe method should be used for its application.
