Company fined after worker is crushed by car while praying

A Liverpool motor vehicle repair company has been fined after a car fell from a two-post car vehicle lift onto a worker who was praying on his break.

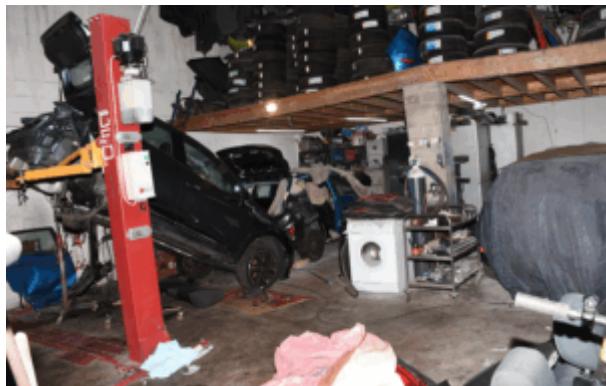
The 56-year-old from Toxteth, Liverpool, was working as a mechanic at the time, at the Marvin Street premises of Car Spa & Tyres Ltd. Mr Hamad was working on a vehicle which had been raised on a two-post lift. Neither swivel arm on one of the lifting columns was locked into position, and as Mr Hamad took a break to pray, the car fell from the lift, crushing him beneath and causing multiple serious fractures.

Garage and prayer mat

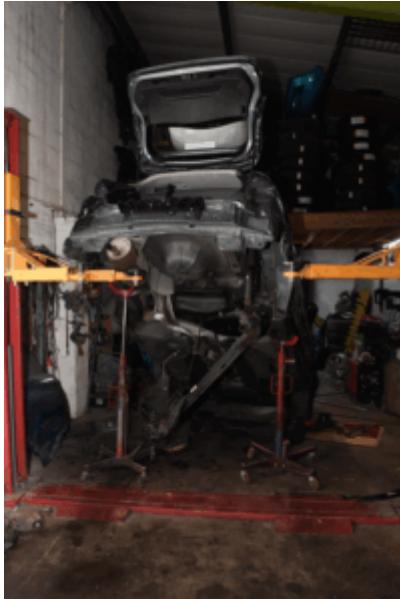
An investigation by the Health and Safety Executive (HSE) found that Car Spa & Tyres Ltd, had failed to put in place a safe system of work, or to sufficiently train their staff, in the proper, and safe operation of the lifting equipment.

Lifting equipment and car

"If Mr Hamad had been suitably trained in the use of the two-post lift, the company had a suitable system of work in place and the swivel arms had been positioned correctly and locked into place this incident would have been avoided.
