Company fined after broken arm forces dad out of work

A manufacturing company has been fined after a dad was drawn into a machine and broke his arm in two places.

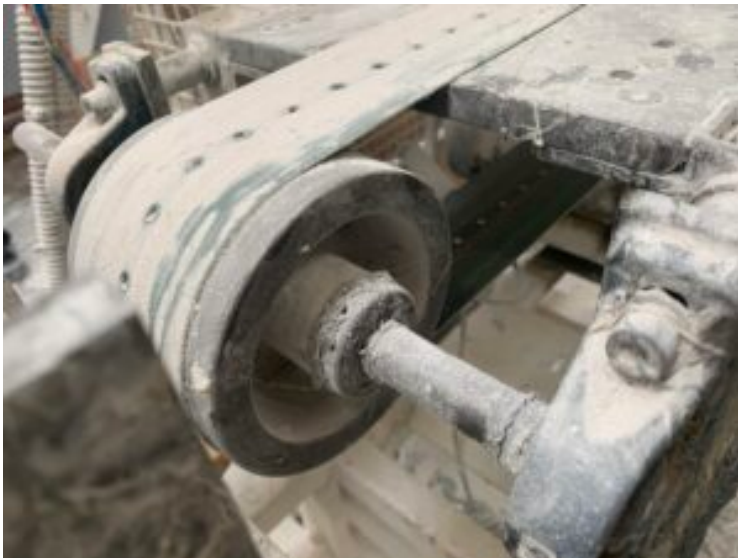
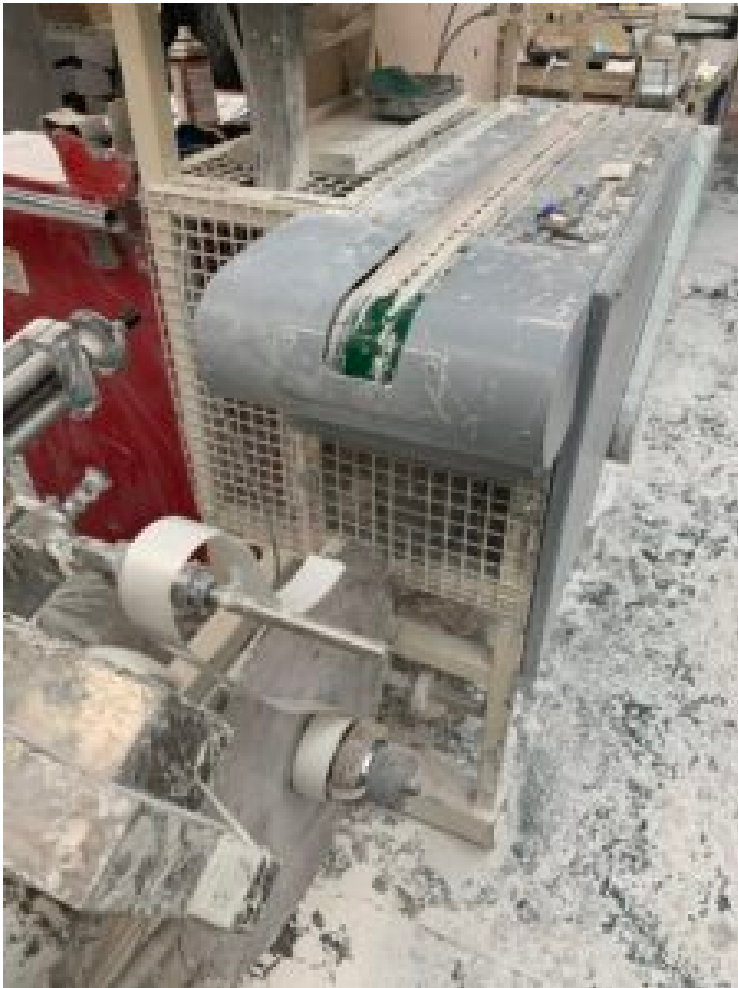
While doing this however, Mr Pearce's left arm became trapped and entangled between the machine's conveyor belt and pulley.

This led to the ulna and radius bones in his left arm breaking with Mr Pearce later requiring surgery to fit metal plates in the arm.

A Health and Safety Executive (HSE) investigation found that HS Butyl Limited had failed to provide guarding to stop its workers from being exposed to

dangerous areas on moving machinery.

HSE inspector Lucy Hacker said: "This incident was wholly avoidable, caused by the failure of the company to provide guarding. Employees should be physically prevented from getting into a position where they can come into contact with dangerous parts of machinery, and experience and procedures alone should not be relied upon to control risk.

"The risk of being drawn in and entangled in dangerous parts of conveyors is a well-known and well-documented machinery risk. The guidance on safe operation of extruders is well established and specifies the requirement for these hazards to be guarded."

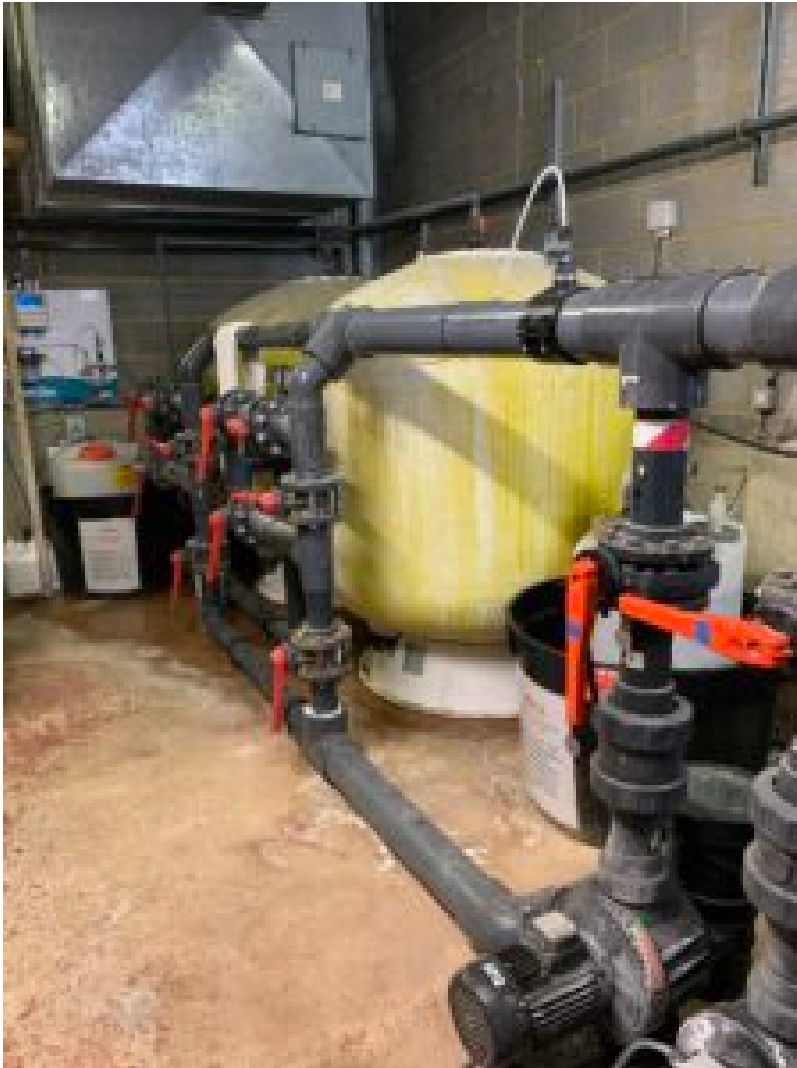
He added sodium hydrogen sulphate, also known as sodium bisulphate, to the pool's sodium hypochlorite tank which caused a reaction and resulted in the release of chlorine gas.

The sodium hypochlorite tank at The Hampshire Clinic

Chlorine gas exposure can be fatal in minutes. Analysis by HSE's Science Division indicated that the maximum volume of chlorine gas produced was nearly 8000 times over the workplace exposure limit (WEL) and nearly 400 times over the Immediately Dangerous to Life or Health (IDLH) Limit.

"Chlorine derivatives in pools are a well-established method of disinfectant provision and the accidental addition of acid to hypochlorite is the commonest cause of chlorine release incidents in pool buildings, it is fortunate that the injuries suffered were not more serious or even fatal."

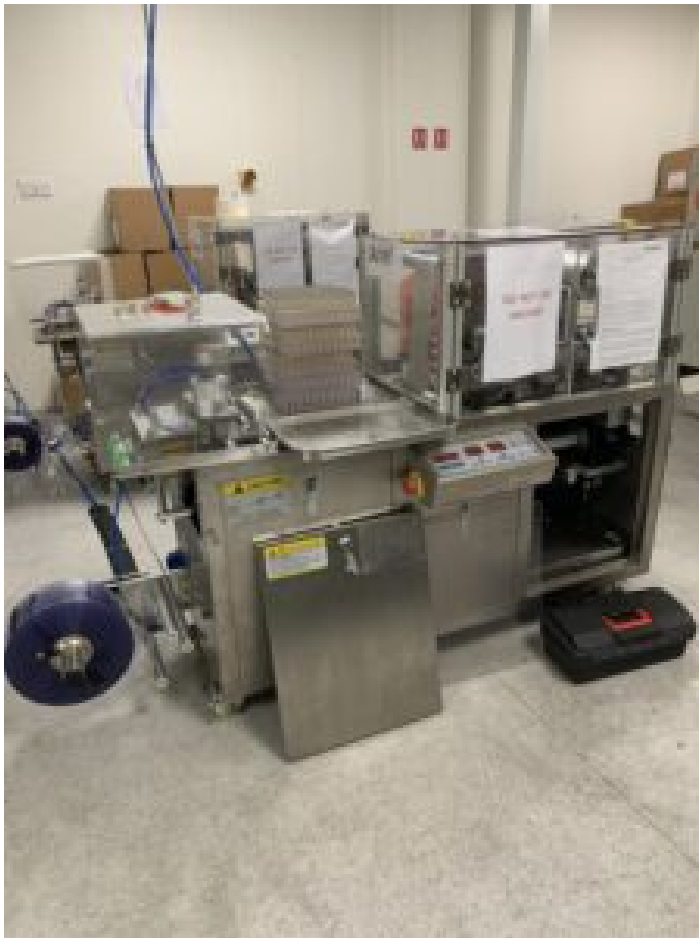
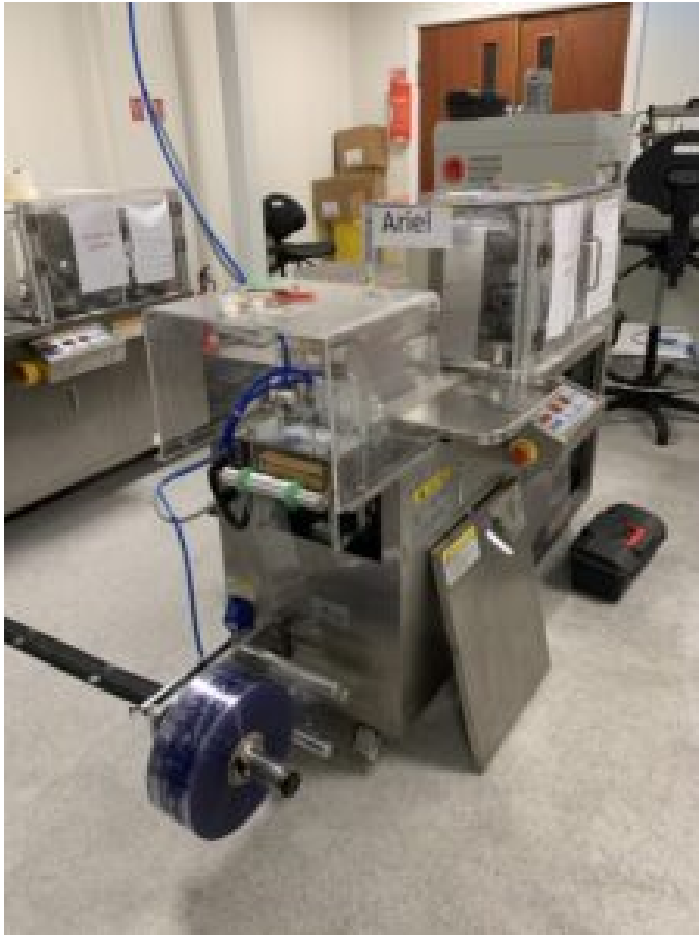
A Health and Safety Executive (HSE) investigation found the machine had recently been imported without any guarding. The engineering team at VN Labs assessed the machine and installed a see-through plastic guard over the top. Despite this, access to dangerous parts of the machine was still possible. There was also no formal written risk assessment for the blister pack machines. The company also failed to implement a safe system for clearing blockages and did not effectively supervise and monitor its working processes.

The packaging machine at VN Labs Ltd

"Companies should recognise the need to ensure machinery is guarded to the standard of UK legislation even when imported from another country because they may have different laws around the standard of guarding."
