# Construction company fined £60,000 after worker falls through unprotected floor opening

## Father and son sentenced for carrying out illegal gas work

# Cornish farmer fined after cow attacks left walkers fearing for their lives

## **Construction company fined after worker crushed by collapsing wall**

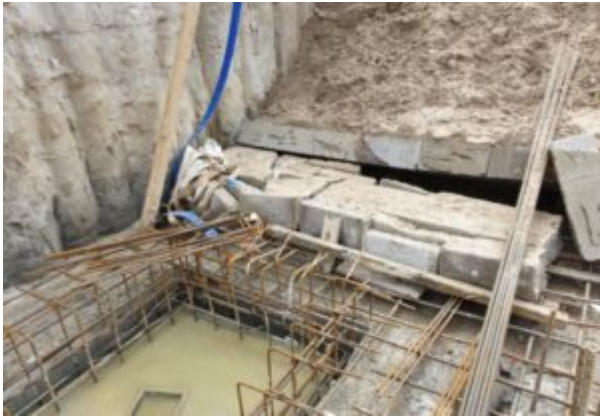
The court heard how the breeze block wall had been back-filled too early, before the mortar had properly set. The wall collapsed while Mr Grant was working nearby, crushing him against the concrete floor of the excavation.

The collapsed wall where Mr Grant was working on the excavation

The investigation identified that there was no temporary works design for the blockwork wall, nor for any other temporary work structures at the site. The company had failed to appoint either a temporary works coordinator or a temporary works supervisor, despite this being highlighted as a serious concern in a safety report issued eight days before the incident.

Without a temporary works procedure in place, groundworkers backfilled the wall prematurely, leading directly to its collapse.

After the hearing HSE inspector, Alexander Ashen, said: "The correct design and execution of temporary works is an essential element of risk prevention in construction.
