# Construction company fined after worker crushed by collapsing wall

- Worker critically injured after wall collapsed into excavation.
- Temporary works were not designed, planned or managed.
- HSE guidance on temporary works is available.

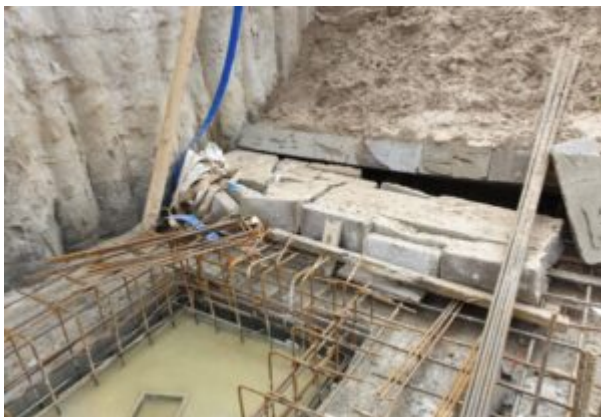
The court heard how the breeze block wall had been back-filled too early, before the mortar had properly set. The wall collapsed while Mr Grant was working nearby, crushing him against the concrete floor of the excavation.

The collapsed wall where Mr Grant was working on the excavation

Without a temporary works procedure in place, groundworkers backfilled the wall prematurely, leading directly to its collapse.

The investigation identified that there was no temporary works design for the blockwork wall, nor for any other temporary work structures at the site. The company had failed to appoint either a temporary works coordinator or a temporary works supervisor, despite this being highlighted as a serious

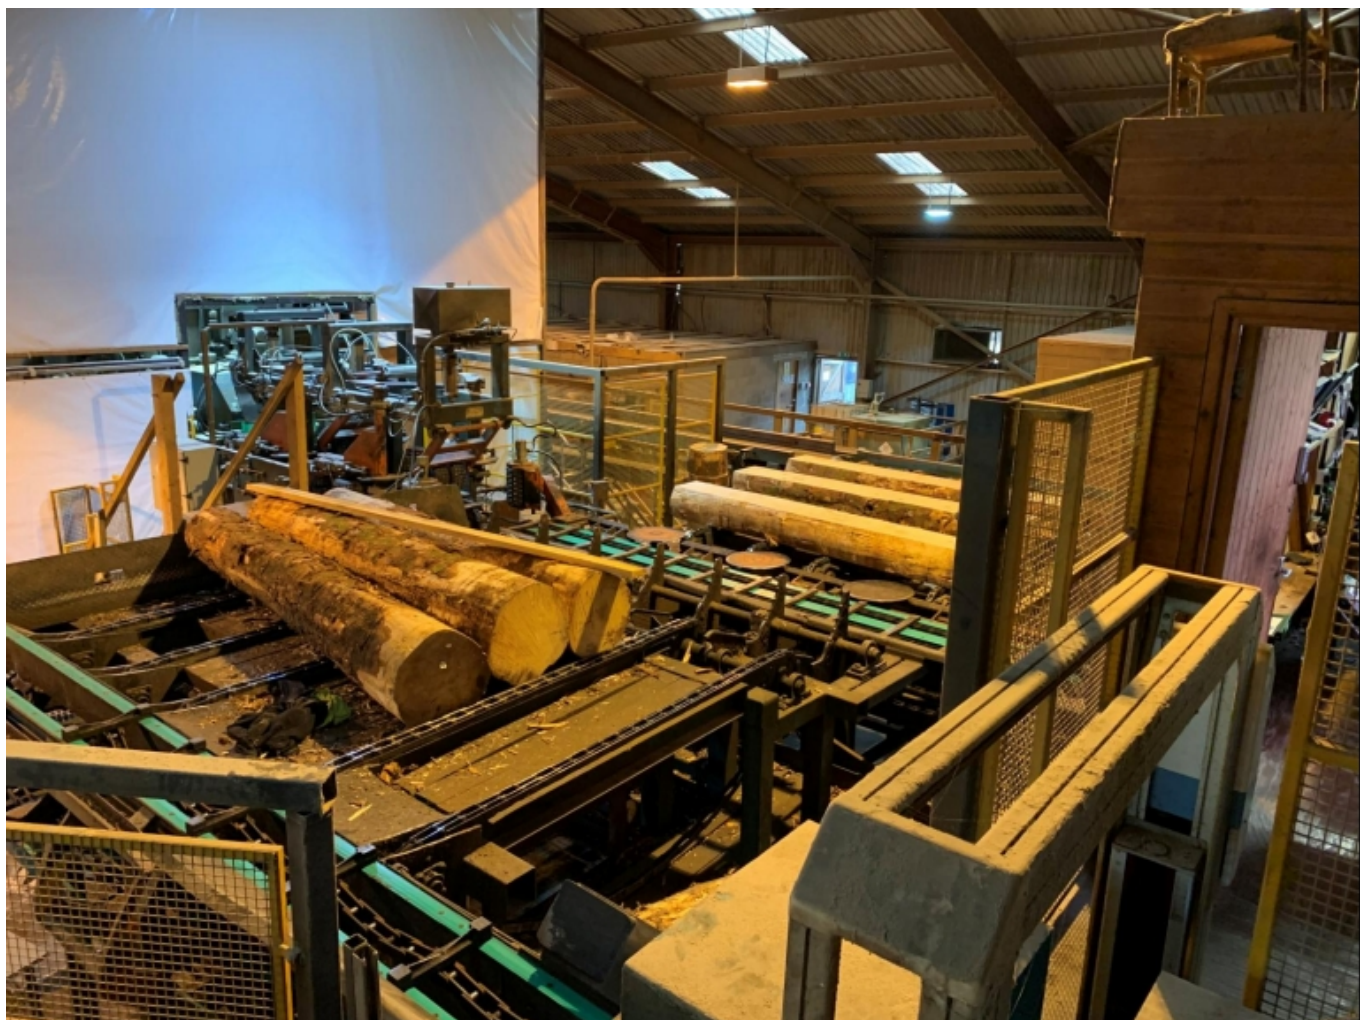
Robert Stubbs, 37, sustained life-changing injuries when clearing a jammed log on a machine in May 2021. Mr Stubbs climbed onto a stationary conveyor bed and used a metal pole to move a log. The conveyor started to move unexpectedly, dragging his legs across the moving chains and trapping them against a stop plate. Subsequently Mr Stubbs had his right leg amputated below the knee and sustained significant injuries to his left leg.

An investigation by the Health and Safety Executive (HSE) found that E.T.C. Sawmills Limited failed to adequately assess the risks and devise and implement effective measures to prevent access to the dangerous moving parts of the Quad Saw machine or to stop the movement of the dangerous parts before people entered the danger zones. Additionally, the company failed to provide employees with safe systems of work or suitable and sufficient information, instruction, training and supervision to enable safe operation of the machine.

ETC Sawmills Factory

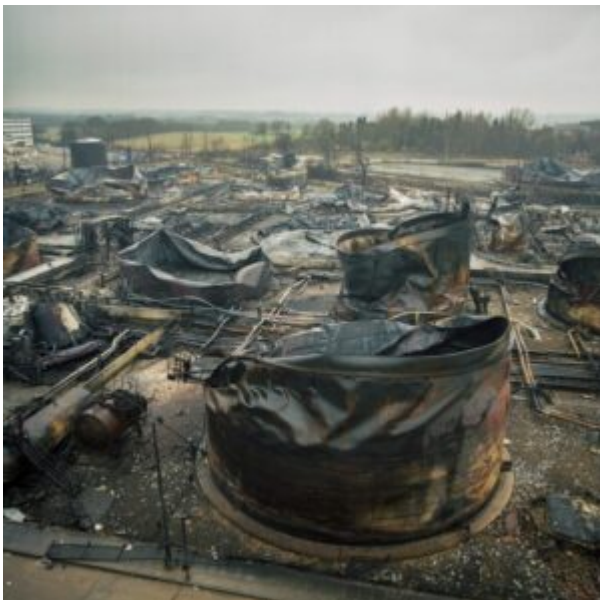
In the early hours of Sunday 11th December 2005 explosions occurred at Buncefield Oil Storage Depot, Hemel Hempstead, Hertfordshire.

In the early hours of 11 December 2005, a storage tank at the Buncefield oil storage depot overflowed, releasing a massive petrol vapour cloud that spread beyond the site perimeter and ignited. The resulting explosions and fires caused widespread damage and disruption, forcing thousands of residents and businesses to evacuate.

The investigation identified systematic failings in tank level monitoring, overflow prevention and safety management systems. Weak oversight and inadequate controls allowed large quantities of petrol to overflow undetected, leading to the release of a vapour cloud that ignited with catastrophic force.

- The Buncefield Standards Task Group (BSTG) – a joint regulator-industry initiative – developed stronger standards for fuel storage and transfer operations
- The Major Incident Investigation Board (MIIB) published a series of influential reports identifying root causes and recommending wide-ranging reforms to safety leadership, management systems and emergency planning
- The Process Safety Leadership Group (PSLG) was created to oversee implementation, producing its 2009 final report which set out new benchmarks for overfill prevention, automatic shutdown, secondary containment and process safety management.

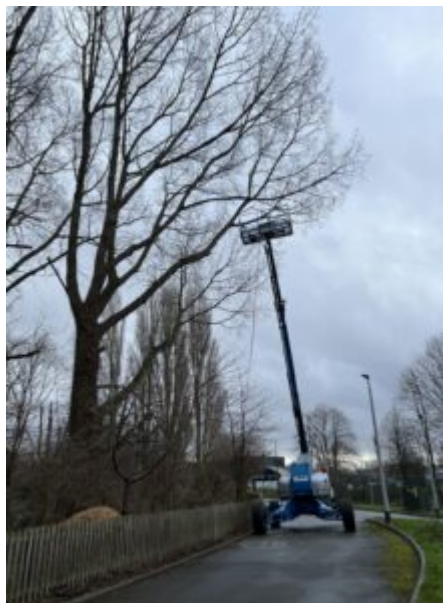
An employee of AP Tree Specialists Ltd had been carrying out tree surgery from the basket of a mobile elevating work platform (MEWP) at a mobile site in Derby on 25 January 2024. When the machine stopped working while elevated, there was no one on site who could bring the basket safely to the ground. The employee attempted to abseil from the basket, resulting in a fall to the ground.

The basket of a mobile elevating work platform (MEWP)

An investigation by the Health and Safety Executive found that AP Tree Specialists Ltd failed to plan, appropriately supervise and carry out work at height in a safe manner. The company had not completed a suitable and sufficient risk assessment for work at height activities, and employees were not appropriately trained in the use of lifting equipment.

The Work at Height Regulations require employers to ensure that work at height is properly planned, appropriately supervised, and carried out safely. Where lifting equipment is used, HSE guidance states that operatives must receive appropriate training, and that rescue planning, equipment and personnel must be considered as part of site assessment. Further guidance is freely available in HSE's [Safe Use of Lifting Equipment \(LOLER\) Approved Code of Practice](#).
