Manufacturing firm fined after apprentice suffers serious injuries

A manufacturing company in Newbury has been fined £187,600 after the shirt of an apprentice got caught in machinery.

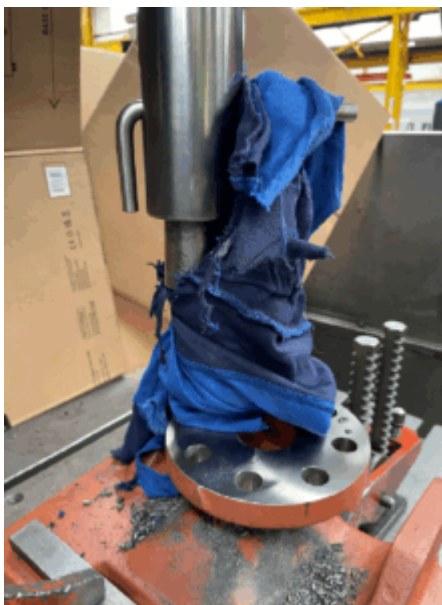
The radial-arm drill

An investigation by the Health and Safety Executive (HSE) found that Power and Energy International had failed to take appropriate measures to ensure the safety of their employees. The company's radial-arm drills did not have adequate guarding. Machine operators, including Harry, had not been properly trained on using the safety features. The company was also found to have made modifications to the radial-arm drill which increased the risk of operators getting caught and pulled into the machine.

HSE guidance states employers must properly assess risks and take effective measures to prevent access to dangerous parts of machinery. This is normally achieved with fixed or adjustable guards but where this is not practicable other protective devices may be needed that stop the movement of dangerous parts. Employers must also ensure that they provide their employees with the necessary level of information, instruction, training, and supervision to enable them to work safely with the equipment they use. Guidance on health and safety in engineering workshops can be found on the HSE website: [Health and safety in engineering workshops – HSE](#)

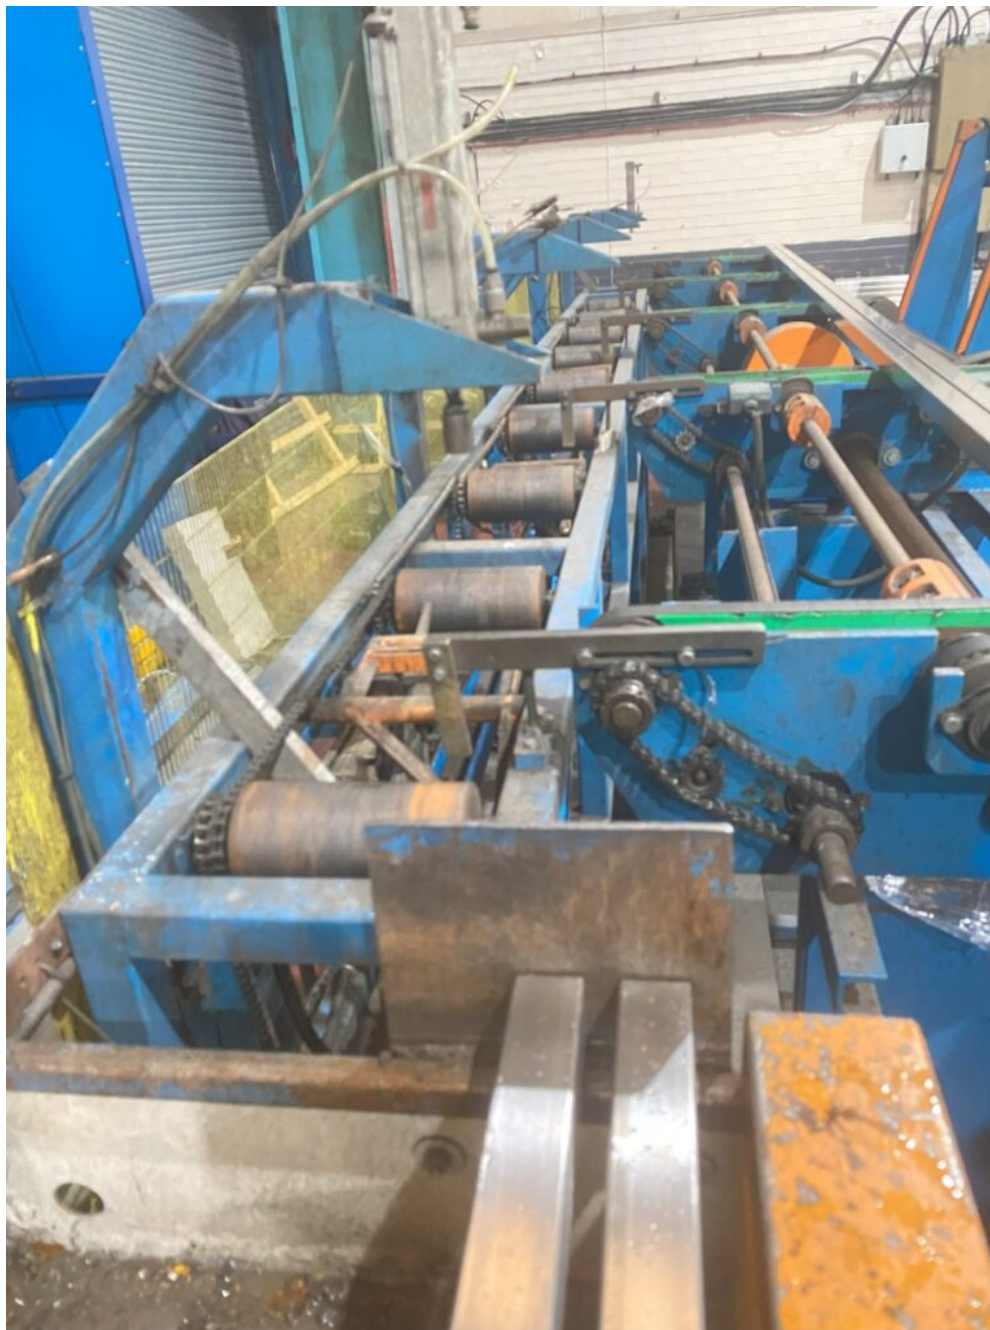
Nathan Watkins was working for FMP West Midlands Limited in Oldbury, West Midlands, on 8 July 2024, when he was loading a tube polishing machine. The machine had faulty rollers, which required Mr Watkins to lean over and straighten the metal tubes. As he did so, his left hand became entangled in the machine's unguarded cogs and chains.

An investigation by the Health and Safety Executive (HSE) found that FMP West Midlands Limited failed to prevent access to dangerous parts of machinery, namely the rotating cogs and chains on the rollers.

Tube polishing machine

HSE provides clear guidance under the Provision and Use of Work Equipment Regulations 1998 on preventing access to dangerous parts of machinery. The first consideration should be physically enclosing the dangerous part with fixed guards to prevent access, which should be securely attached and not easily removed. Further guidance can be found at HSE's website: [Safe use of work equipment. Provision and Use of Work Equipment Regulations 1998. Approved Code of Practice and guidance L22](#))

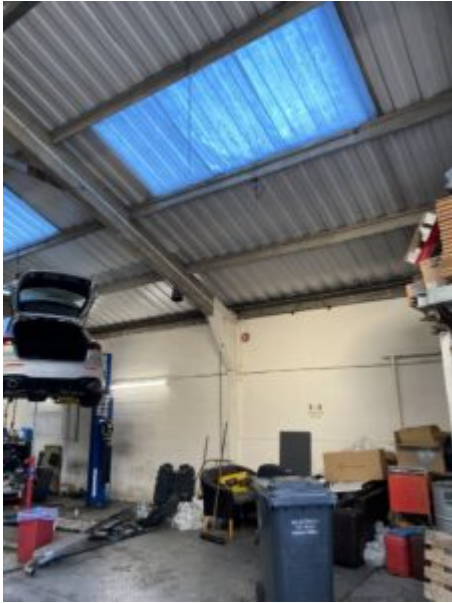
Skylight and area below

The company did not arrange for scaffolding to be erected at the open edges of the roof, nor make adequate arrangements to prevent or mitigate falls through fragile areas of the roof. As there was nothing to prevent or reduce his fall through the skylight, the man fell from the height of the roof to the solid floor below.

“Too many workers are injured or killed every year as a result of falls from height during construction work. These incidents can be prevented if reasonably practicable measures such as scaffolding or netting are put in place to protect workers.”

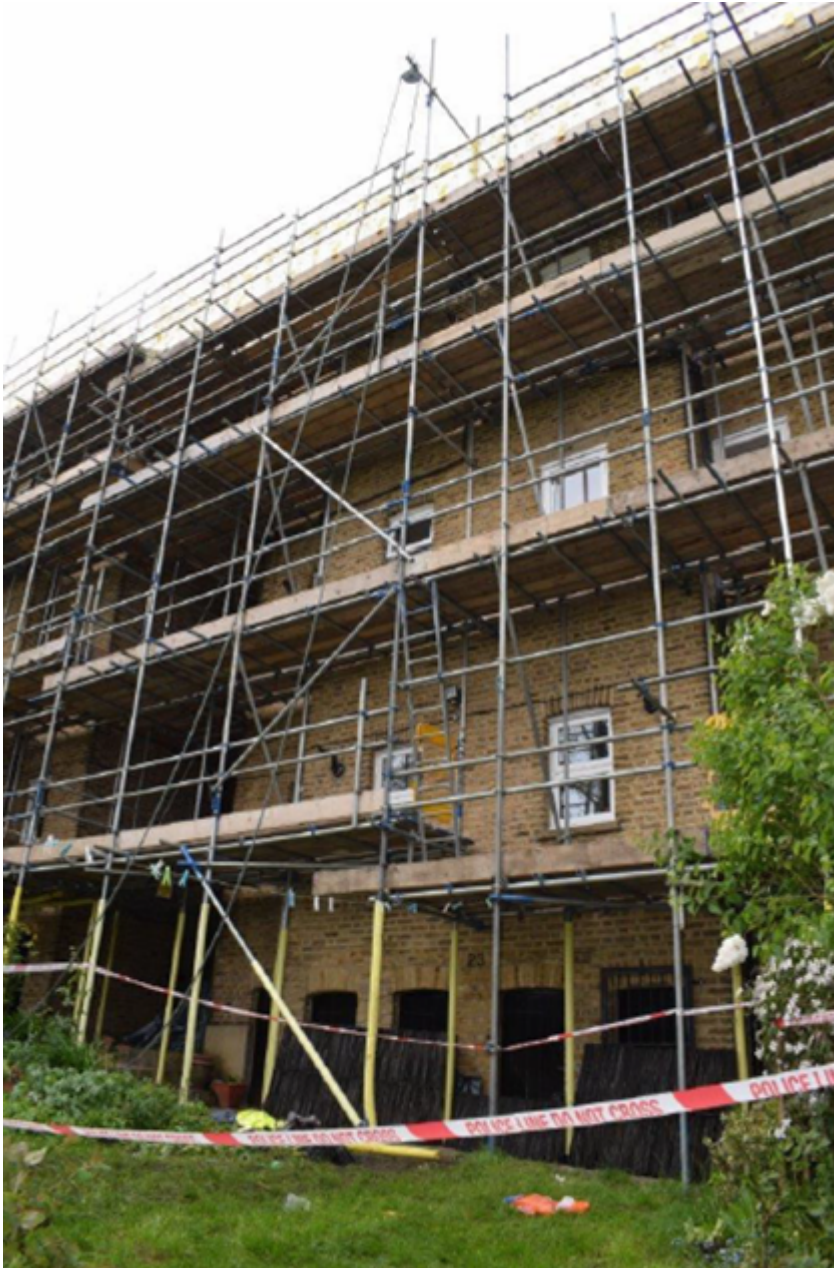
The worker was contracted as a general labourer for Premier Property and Construction Limited on a project managed by Axis Europe Limited at Cathcart Hill, London on 15 April 2024. During an unplanned lifting operation, the load became trapped. When the worker attempted to free it, the released load caused him to be pulled over the edge of the scaffold.

Image of scene

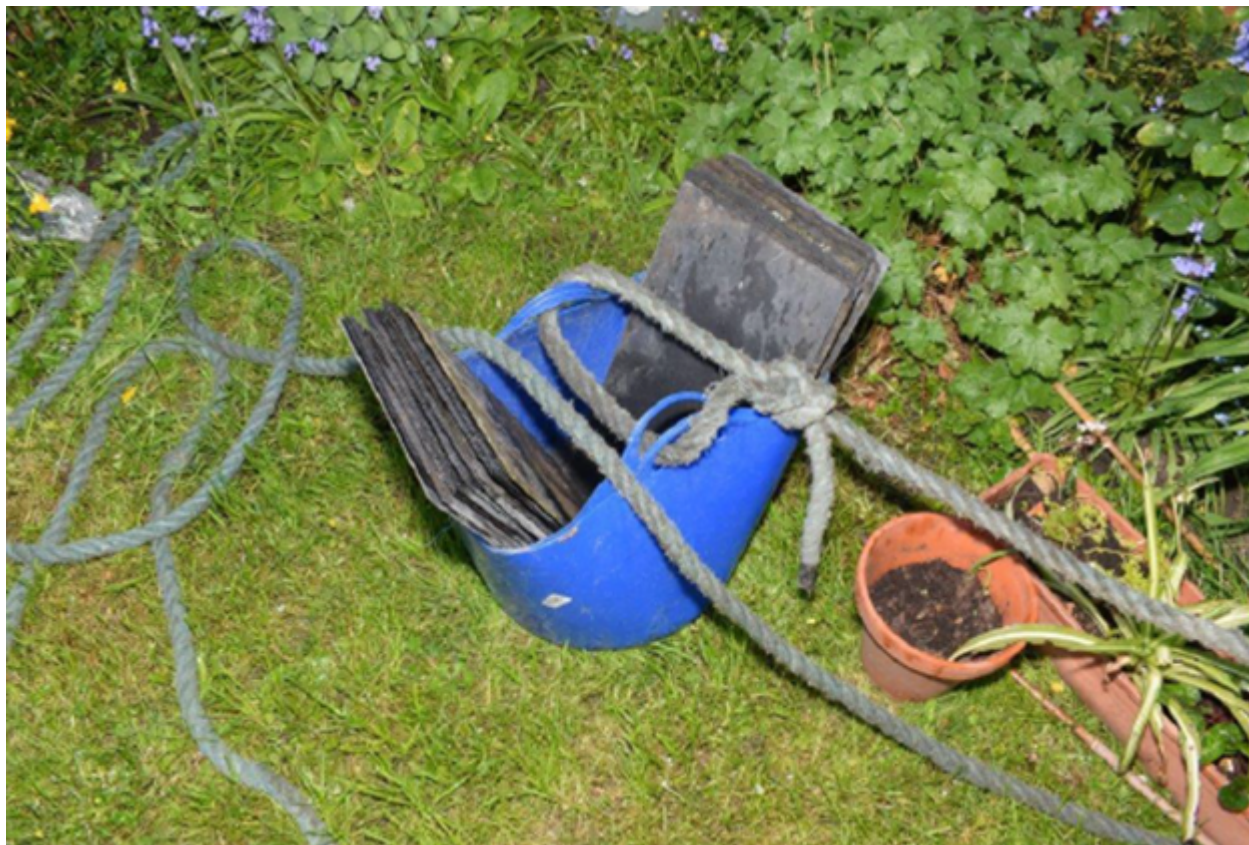
HSE also found that Axis Europe Limited failed to properly manage and monitor the works being carried out by Premier Property and Construction Limited on its site. The principal contractor did not recognise insufficient detail on lifting operations and did not adequately challenge or prevent the use of untested lifting accessories on site.

Image of unsuitable and untested lifting accessory

HSE guidance states that contractors must plan, manage and monitor construction work under their control to ensure risks to health and safety are controlled, with effort proportionate to the project's size, complexity and risks involved. Further guidance can be found at HSE's website: [Managing health and safety in construction – Guidance on the Construction \(Design and Management\) Regulations 2015 – L153](#).
