Waste and recycling company fined after worker injured cleaning machinery

A North East waste and recycling company has been fined £270,000 after an employee was injured while cleaning a waste picking line.

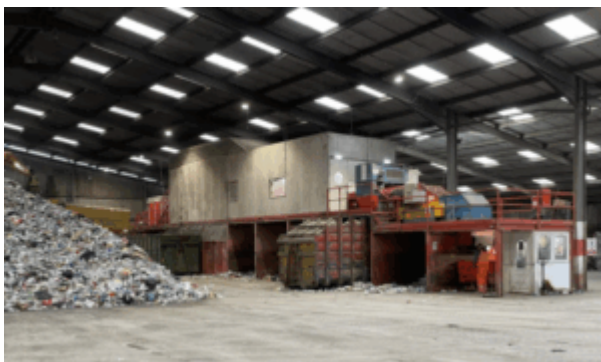
On 24 March 2023, during cleaning of a waste picking line, an employee became trapped in a section of machinery when the line was accidentally switched on.

An investigation by the Health and Safety Executive (HSE) found the company failed to ensure an isolation procedure was correctly implemented while employees were cleaning machinery at its site at Aycliffe Quarry, Aycliffe Village, County Durham.

Machinery at the site at Aycliffe Quarry

The incident occurred when a senior supervisor, restarted the machinery after mistaking the worker in question for a colleague in similar clothing nearby.

HSE guidance highlights the importance of following safe isolation and lock-off procedures before any maintenance or cleaning work is carried out. Employers must ensure all machinery is properly isolated from power sources, and that systems are regularly monitored and reviewed to prevent inadvertent start-up. Further guidance is available here: [The safe isolation of plant and equipment – HSE](#)

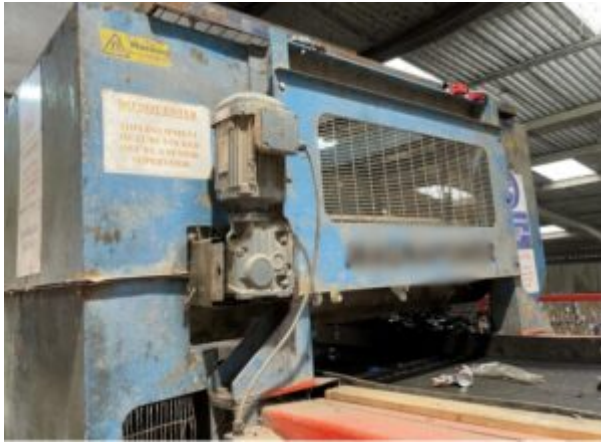
This was not the first serious incident at the site. In December 2015, one worker was killed and another suffered life-changing injuries on a separate waste sorting line due to similar failures to follow proper isolation and lock-off procedures.

Waste sorting line machinery

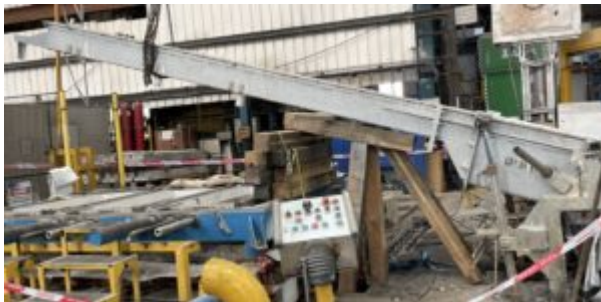
He had been carrying out preparation work for the casting of aluminium blocks from molten aluminium. He was kneeling inside a casting mould, wearing heat resistant clothing, to insert ceramic string around its edges. The hydraulic arm above the mould, which is used to transport molten metal around the foundry, suddenly fell onto him. It is believed the exterior temperature of the arm was around 100°C.

The hydraulic arm post incident

An investigation by the Health and Safety Executive (HSE) found that the arm fell as a result of hydraulic failure. While there was a safety bar intended to prevent the arm from falling, it was not fit for purpose. Bridgnorth Aluminium Limited had not assessed the risks of the hydraulic arm falling and therefore failed to implement a suitable safe system of work to prevent employees from working beneath it.

"The company subsequently implemented simple control measures to prevent it from re-occurring. The process of placing the ceramic string in the moulds is now carried out with the hydraulic arm in the lowered position, and people are restricted from walking under the it when it is raised.
