# Manufacturer fined after employee's fingers severed

## [Plant hire company fined £10,000 after employee struck by falling JCB bucket](#)

## Hartlepool chemical manufacturer fined £50,000 after two serious incidents within three months

# Contractor jailed after 'kind hearted' teen fell to death during demolition works

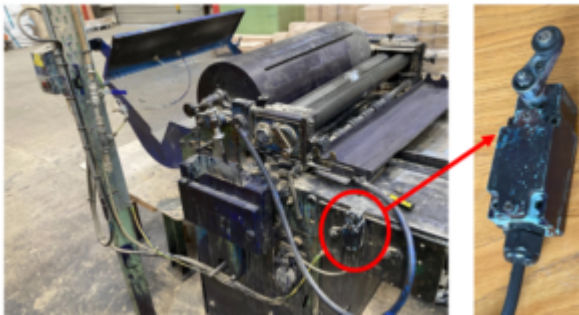
Image from site

A 57-year-old woman was working for Askern UK Limited at its site in South Kirkby, Pontefract on 8 March 2024 when she was able to raise the guard and easily override an interlock to run the rollers of a machine which prints logos. The employee was cleaning the rollers with a paper towel when her fingers were drawn into the nip point, leaving two of her fingers partially severed.

An investigation by the Health and Safety Executive (HSE) found that Askern UK Limited failed to prevent access to dangerous parts of machinery, namely the moving rollers of the printing machine. The investigation also found that the company had failed to adequately maintain the machine or provide employees with suitable training for the printer.

HSE guidance states employers must take effective measures to prevent access to dangerous parts of machinery. This includes ensuring protection devices, such as interlocks, are not easily bypassed or disabled. Further guidance on the [Provision and Use of Work Equipment Regulations 1998 \(PUWER\)](#) is available.

“A suitable interlock and employee training would have prevented this incident”

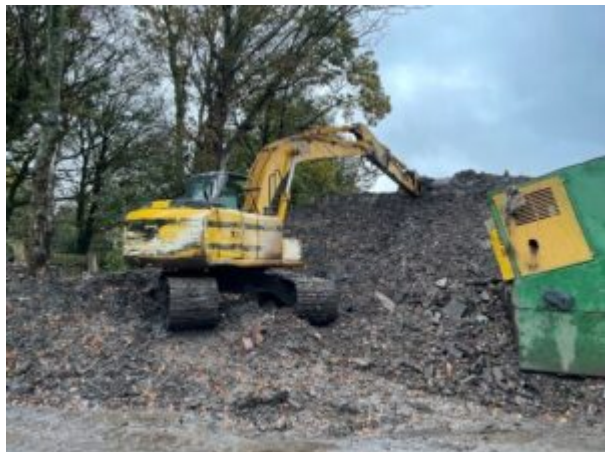
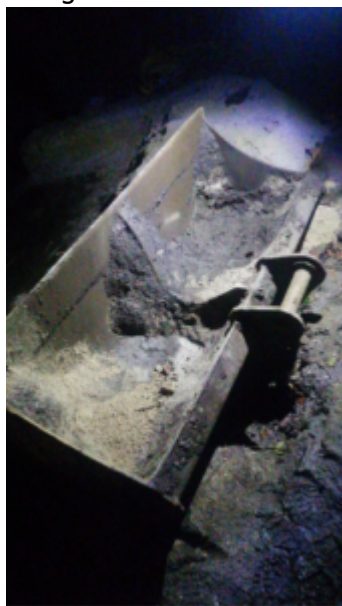
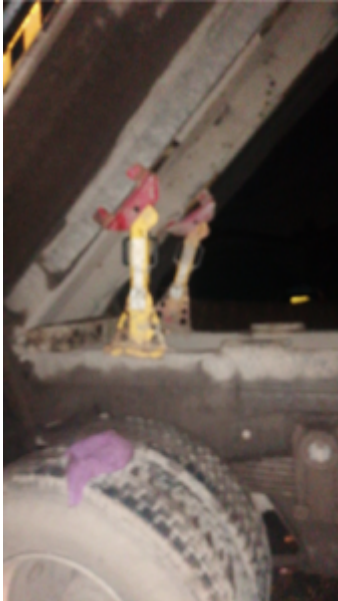
Image from site

On the 24 October 2023, the employee of Salford Grab Hire Limited was assisting a colleague in repairing a broken lifting mechanism on a tipper truck body. A JCB was being used to prop up the tipper body in the raised position when the one-tonne bucket became dislodged and fell.

An investigation by the Health and Safety Executive (HSE) found that Salford Grab Hire Limited had not used appropriate equipment to support the tipper body during repairs. The bucket being used to prop up the body did not have a quick hitch or retaining pin, causing it to become dislodged and fall.

HSE guidance on [health and safety in motor vehicle repair and associated industries](#) states that elevated vehicle load areas, such as those on tipper lorries, should be effectively propped if access is needed below them. Props should only be used on firm, level ground and must be designed to adequately carry the loads placed on them.

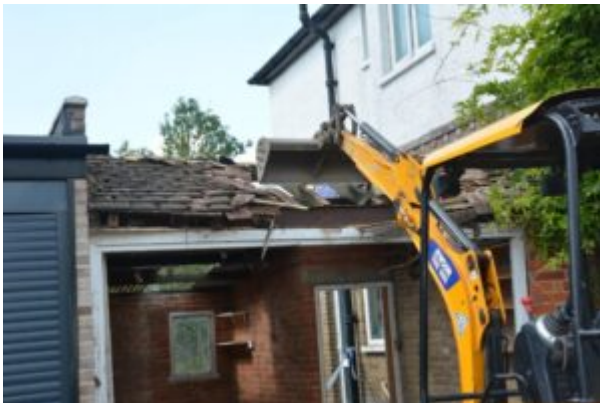
On 16 August 2023, Tom, who was local to the area, was on the garage roof removing tiles and other materials when he fell through an opening and suffered severe head injuries. He was taken to hospital but he died several weeks later on 23 September.

An investigation by the Health and Safety Executive (HSE) found that Hill, 59, of Ashford in Middlesex, had put no measures in place to prevent a fall from height, despite the clear risk. Work was being carried out directly from the roof with no scaffolding, decking, or other protective systems to prevent a person falling through or from the structure.

Thomas fell through the roof of this garage as it was being demolished

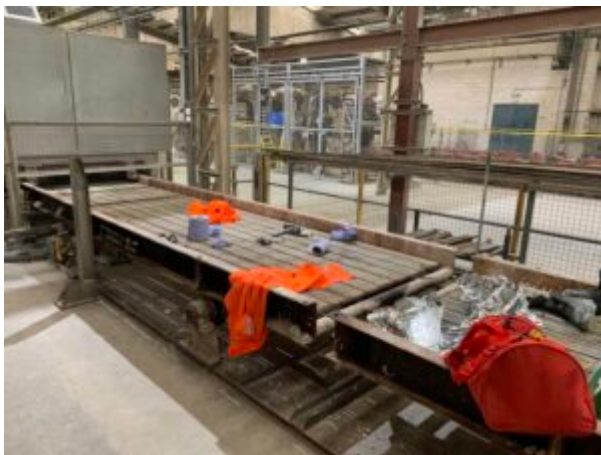
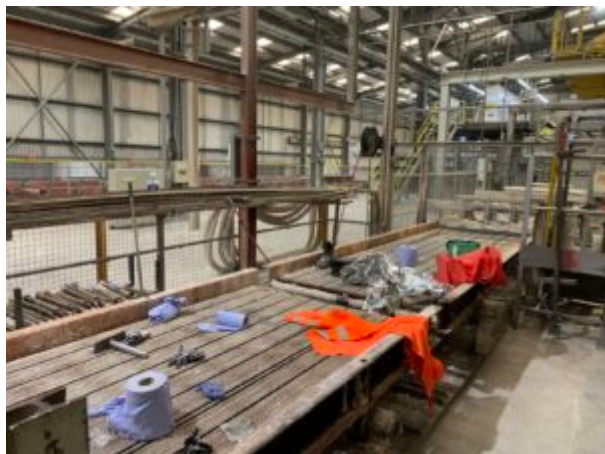
Images from site

Richard entered the fenced area through an interlocked gate which, when opened, was supposed to prevent frames from moving on that section of the track. As he was working on the stationary frame, another frame moved along the trackway into the section and struck him. Richard's legs were crushed and pinned between the two frames.

An investigation by the Health and Safety Executive (HSE) found that Tarmac Building Products Limited failed to prevent access to dangerous parts of machinery, namely the moving frames on the track, or prevent the frames from moving when employees entered the danger zone. The interlocked gate which employees used to enter the frame cleaning area did not stop the power on the preceding sections of track and would therefore not prevent a frame from moving into this area when employees were working.

HSE guidance on [safe use of work equipment](#) states that employers must take effective measures to prevent access to dangerous parts of machinery.
