HS2 contractor fined £400,000 after tipper truck driver injured

- 20-tonne tipper truck fell off edge of excavation ramp
- The driver of the truck suffered multiple injuries
- The joint HS2 venture set up by Skanska Construction UK Limited, Costain Limited and Strabag AG

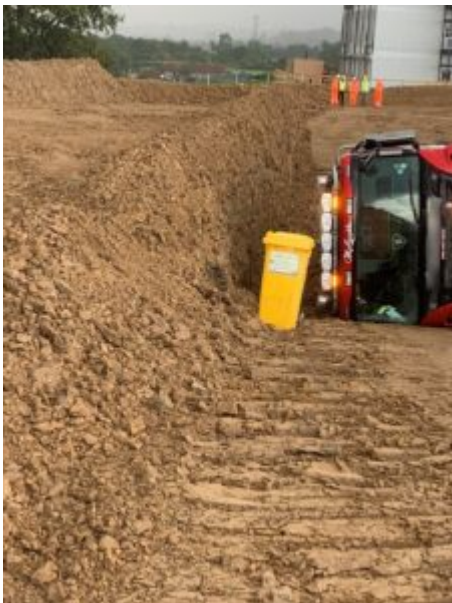
The tipper truck fell approximately two metres and landed on the driver's side. The man behind the wheel suffered a broken nose, cut hand, and a shoulder injury.

The 20-tonne truck ended up on its side after falling off excavation edge

Inspectors from the Health and Safety Executive (HSE) visited the site after the incident and found that there were no signs on the haulage routes being used. They also identified that there was no edge protection in place to prevent vehicles going over the edge of the ramp, and that excavations adjacent to some of the vehicle routes had unsupported, vertical faces which were at risk of collapse.

HSE guidance on the management of vehicle movements on construction sites can be found in the HSE publication HSG 144, [The safe use of vehicles on construction sites](#). This states that physical barriers, such as safety banks, should be provided at the edges of excavations. Guidance on excavations can also be found at [Excavations – HSE](#). Haul roads on construction sites are also classed as temporary works and guidance can be found at [Temporary Works – HSE](#).

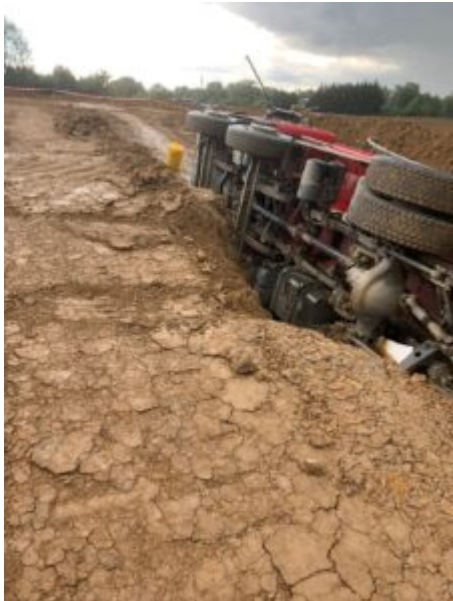
The subsequent HSE investigation found that on the morning of the incident, the SCS earthworks team changed their working area after an Align JV representative found the original material could not be used. This meant moving the excavator's loading position and creating a new traffic route – but the change inadvertently left an unprotected edge on the bank above.

The suffered several injuries in the incident

When the first ACE tipper truck driver used the higher-level bank instead of the intended new route, his vehicle slipped on the ramp. The next ACE driver followed the same path – and his vehicle veered off the edge of the bank.
