Manufacturer fined after an agency worker was dragged into a press roller

A manufacturing company has been fined after an employee's arm was dragged into a press roller.

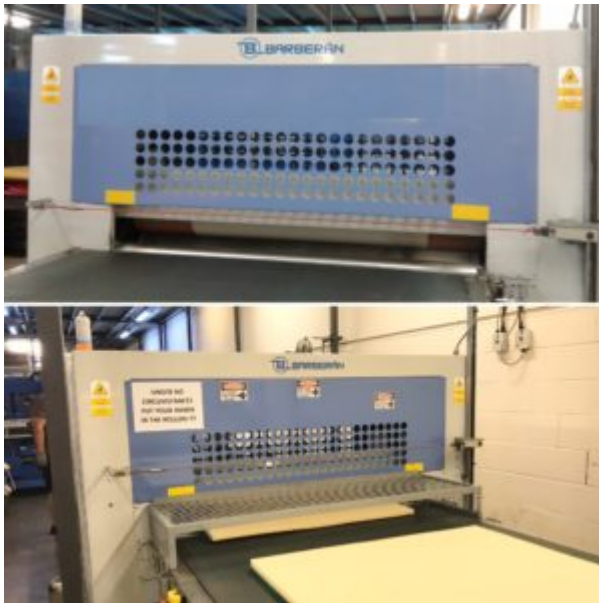
1. The Health and Safety Executive (HSE) is Britain's national regulator for workplace health and safety. We prevent work-related death, injury and ill health through regulatory actions that range from influencing behaviours across whole industry sectors through to targeted interventions on individual businesses. These activities are supported by globally recognised scientific expertise. www.hse.gov.uk
2. More about the legislation referred to in this case can be found at: www.legislation.gov.uk/
3. HSE news releases are available at <http://press.hse.gov.uk>
4. Picture illustrates the press roller with and without a guard.

An investigation by the Health and Safety Executive (HSE) found that the company failed to provide a tunnel guard on the press roller to prevent access to the rollers.

Speaking after the case, HSE inspector Carla Barron, said: "This incident could have been avoided had the company properly assessed the guarding arrangements on the machine when it was installed. Unfortunately access to in-running rollers is a common cause of injury but it can be easily avoided by providing effective control measures such as the provision of tunnel guards."
