Mining company fined after electrician killed at Europe's only underground quartz sand mine

HSE investigation findings

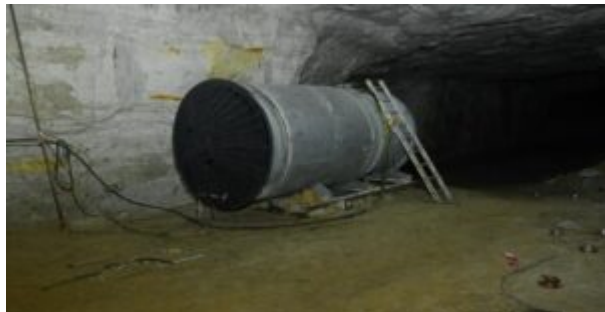
The fan involved had originally formed part of a single in-line assembly unit with a sister fan. In June 2020, the decision was taken at the mine to split this single unit into two separate fans. HSE investigators found that the hazards arising from this modification had not been properly identified or managed. No written risk assessment was produced, no commissioning documents were created, and no records of any management discussion about the separation could be provided.

The sister fan of the one involved in the incident – the two had originally been together as one unit

Critically, the splitting of the unit left the rotating parts of the Number 2 fan significantly closer to its intake guard than was safe. The fan blades were just 43mm – less than two inches – from the leading edge of the duct. The relevant guarding standard required a distance of at least 200mm, which could have been achieved through appropriate nose cone or cage-type guarding.

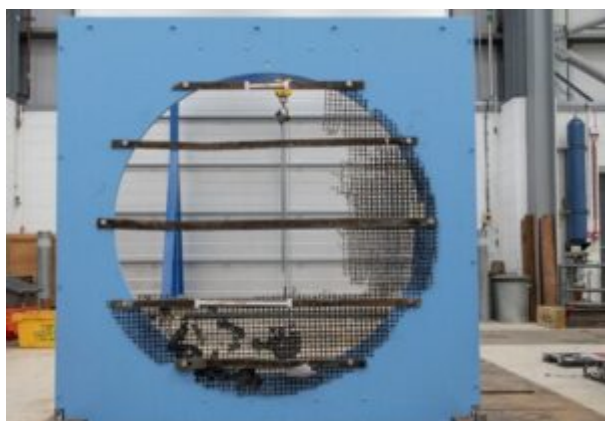
To cover the exposed intake, guards were fabricated on-site from two sheets of metal square lattice mesh, which HSE inspectors determined was poorly designed. The metal bracing straps were fitted on the outside of the mesh panels rather than the inside, providing no additional structural strength. The exhaust end of the fan remained entirely unguarded.

When inspectors examined the fan the day after the incident, the intake guard was found to be in a seriously degraded condition. Significant areas of mesh were missing, particularly around the fan's impeller hub. Wire and mesh pieces recovered from the floor showed heavy corrosion on their broken ends, indicating they had been in that condition for some time – not freshly broken during the incident. Further pieces of mesh had been ejected through the fan during the incident itself. Had the guard been properly designed and maintained, it is likely it would have prevented the fatal incident.

Significant areas of mesh were missing, particularly around the fan's

impeller hub

Compounding these failures, the two fans had not been listed on the mine's Mechanical Asset Register. No inspection checklists or maintenance records for them could be provided. While electrical inspections had been recorded, the degraded condition of the inlet guard had not been identified during those processes.

"Our investigation found that when the fan was modified, the risks were not identified. The guarding that was put in place was inadequate from the outset, and its deteriorating condition went unnoticed because there was no proper maintenance regime in place.
