# Sole trader fined after worker injured in fall from height

- Worker suffered life-changing injuries after falling through fragile rooflight.
- HSE investigation found no measures in place to prevent or mitigate a fall.
- Incident highlights ongoing risks of working at height in construction.

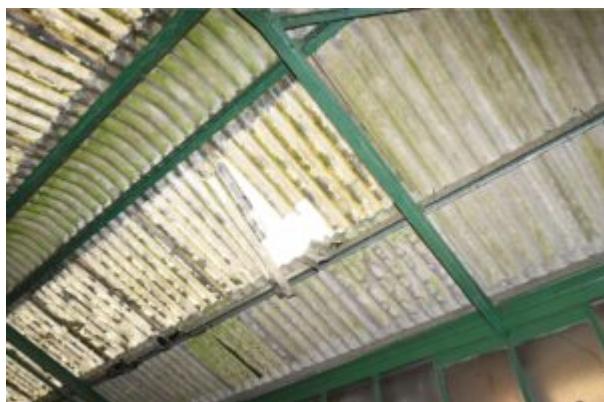
The hole left in the roof

While walking next to the unguarded edges of the roof, he approached a fragile roof covering above a service road. He stepped onto a rooflight, fell through it, and sustained serious, life-changing injuries including a fractured skull and cheekbone, a fractured leg and a broken wrist.

An investigation by the Health and Safety Executive (HSE) found that Daniel Jenner had failed to implement any work-at-height measures to prevent workers from falling from the unguarded edges of the roof or through the fragile roof itself. There were no measures in place to mitigate for either the distance or the impact of a fall.

“This was a tragic but avoidable incident, where an individual suffered life-changing injuries due to working at height. Had suitable control measures been implemented, such as fall prevention or fall mitigation measures, this incident would not have occurred.

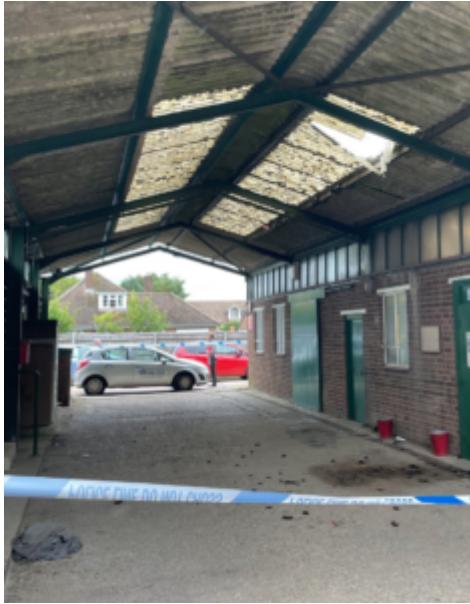
Police at the scene of the fall
