Landlord of lock up garages fined for asbestos failings

Company prosecuted after employee injured during loading operations

Restaurant owner fined after disturbance of asbestos

Industrial staircase installer fined after worker trapped

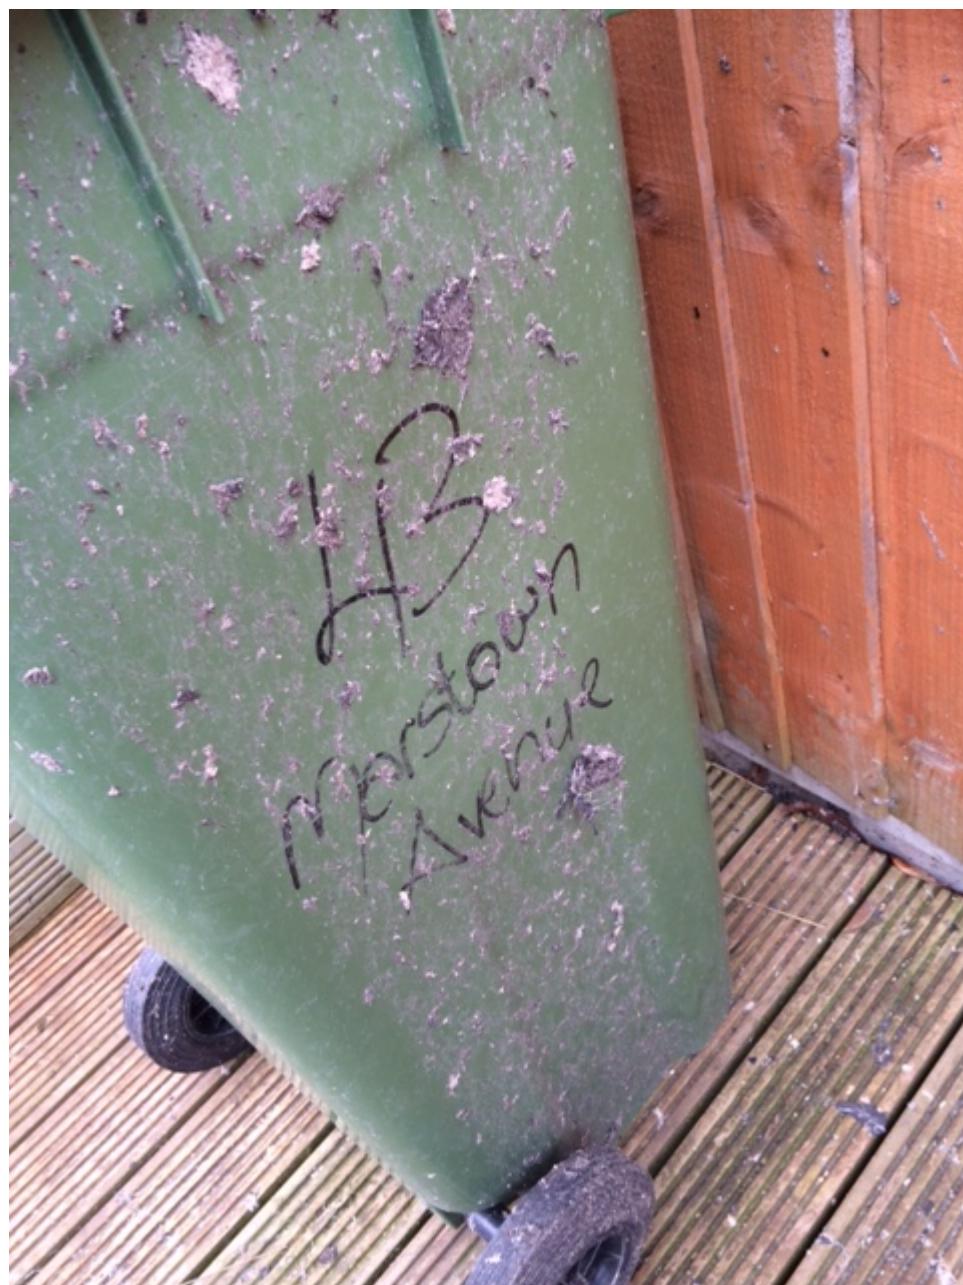
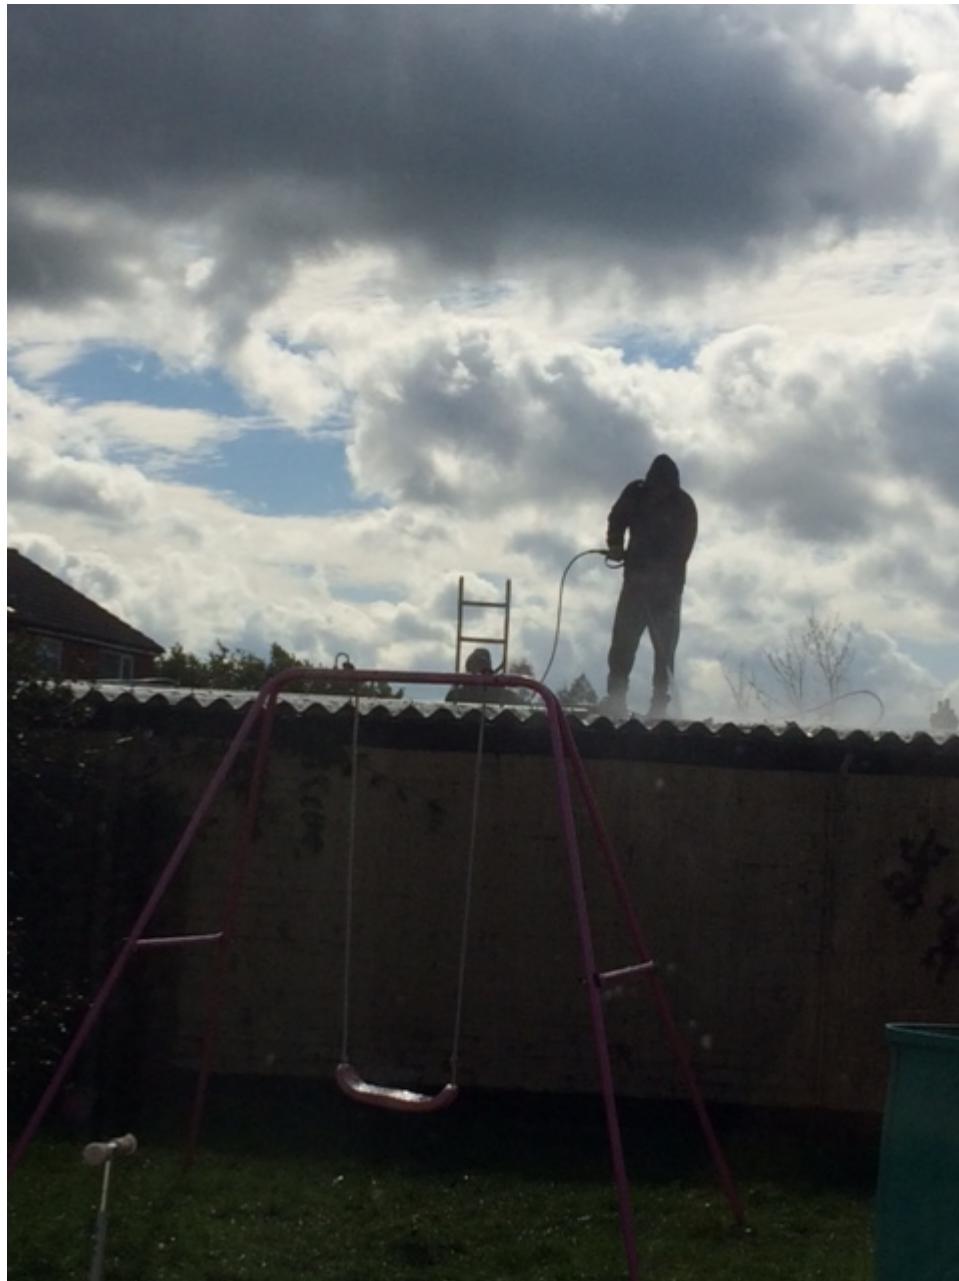
Leicester Crown Court heard that work carried out by Paul Whitaker in March and April 2016 spread asbestos over a number of domestic gardens after a powered jet-wash was used to clean asbestos cement roof sheets. The power of the water jet caused asbestos to be dislodged from the roofs, and spread across the gardens, the garage units themselves, and nearby Network Rail land. This put members of the public at risk of exposure to asbestos fibres – a Class 1 carcinogen.

An investigation by the Health and Safety Executive (HSE) found that work should have been planned to include the use of basic precautions as detailed in published and widely recognised guidance for working with asbestos cement. Low energy cleaning methods and proper protective measures would have prevented the release of asbestos fibres thus eliminating much of the risk.

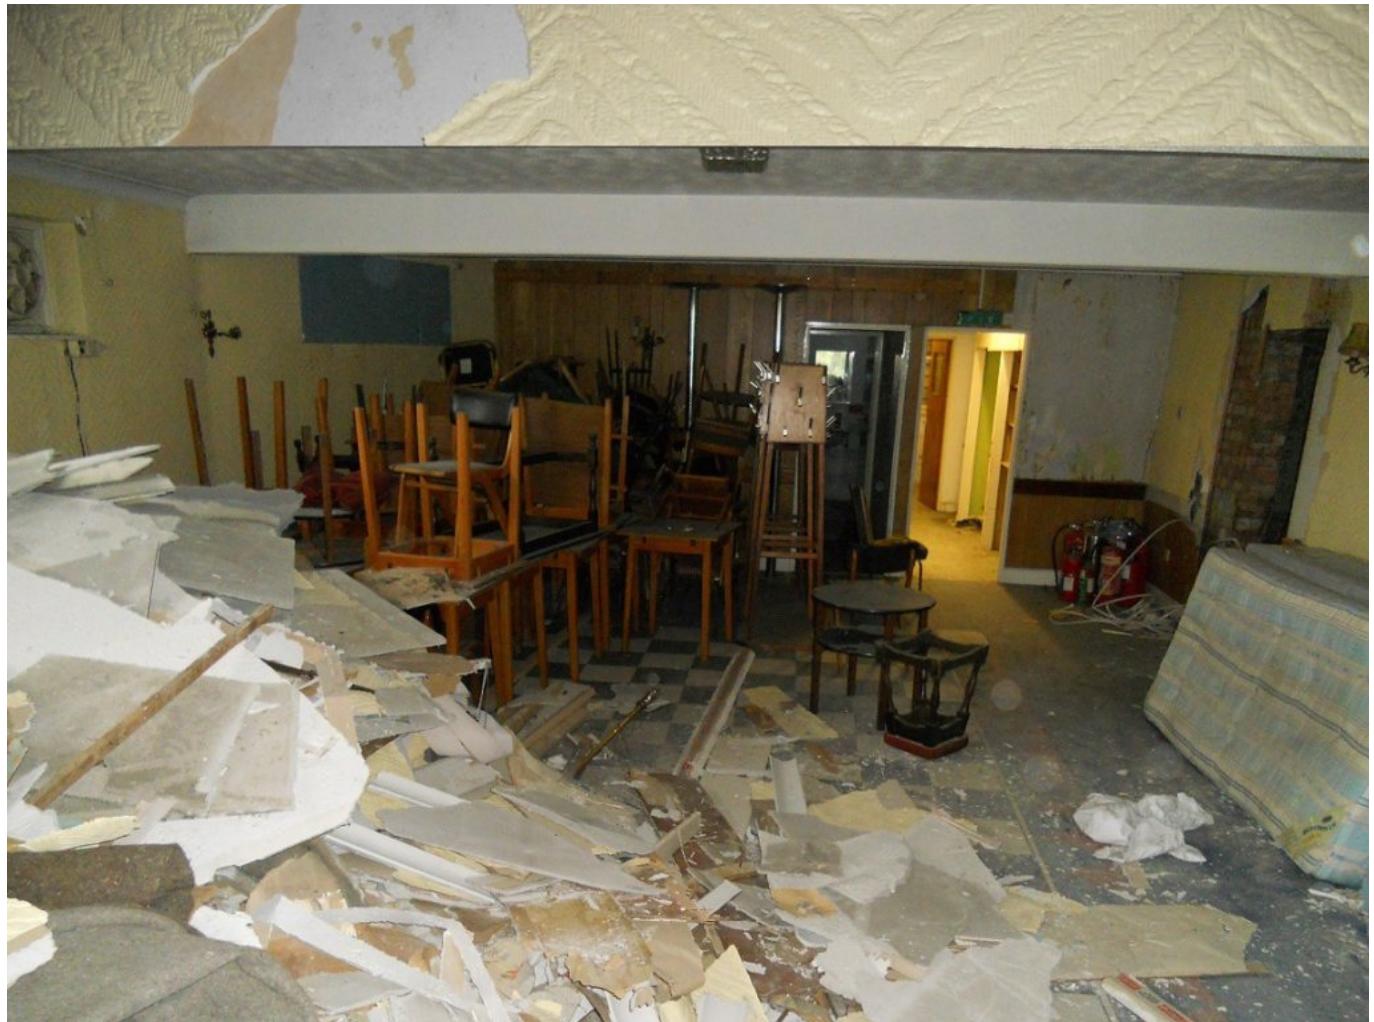
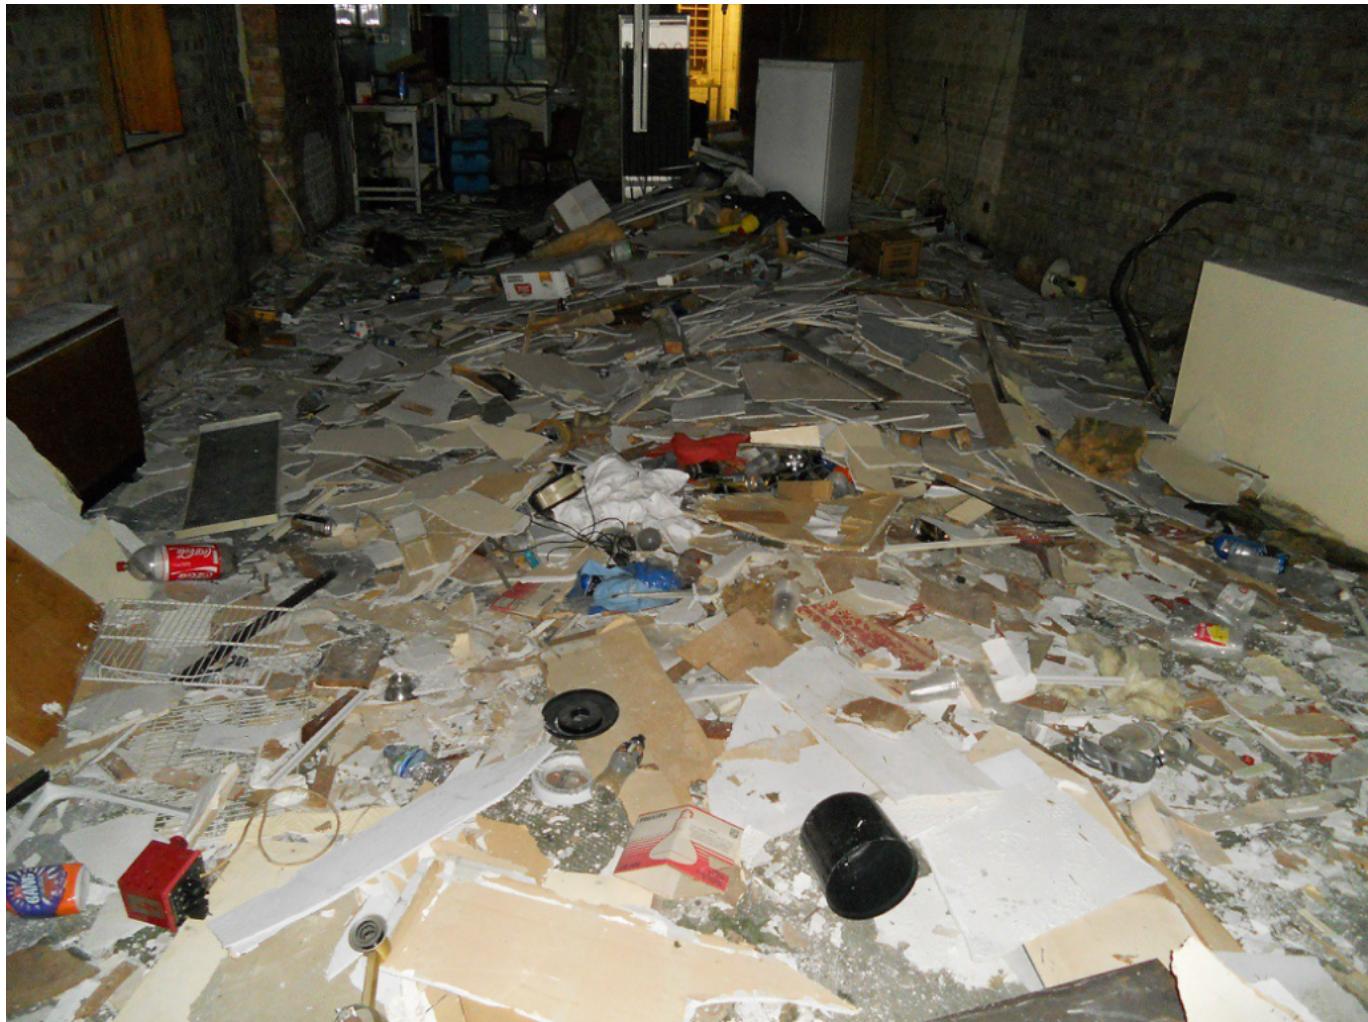
Chelmsford Magistrates' Court heard that during September 2016, above the Marco Polo restaurant on Lower Southend Road, Wickford, asbestos insulation board was removed and broken up which resulted in workers being exposed to asbestos fibres. An asbestos survey was only carried out after the asbestos had been disturbed.

An investigation by the Health and Safety Executive (HSE) found that a management asbestos survey and a refurbishment and demolition asbestos survey had not been completed prior to the work starting, and the work had not been completed by a licenced asbestos contractor.

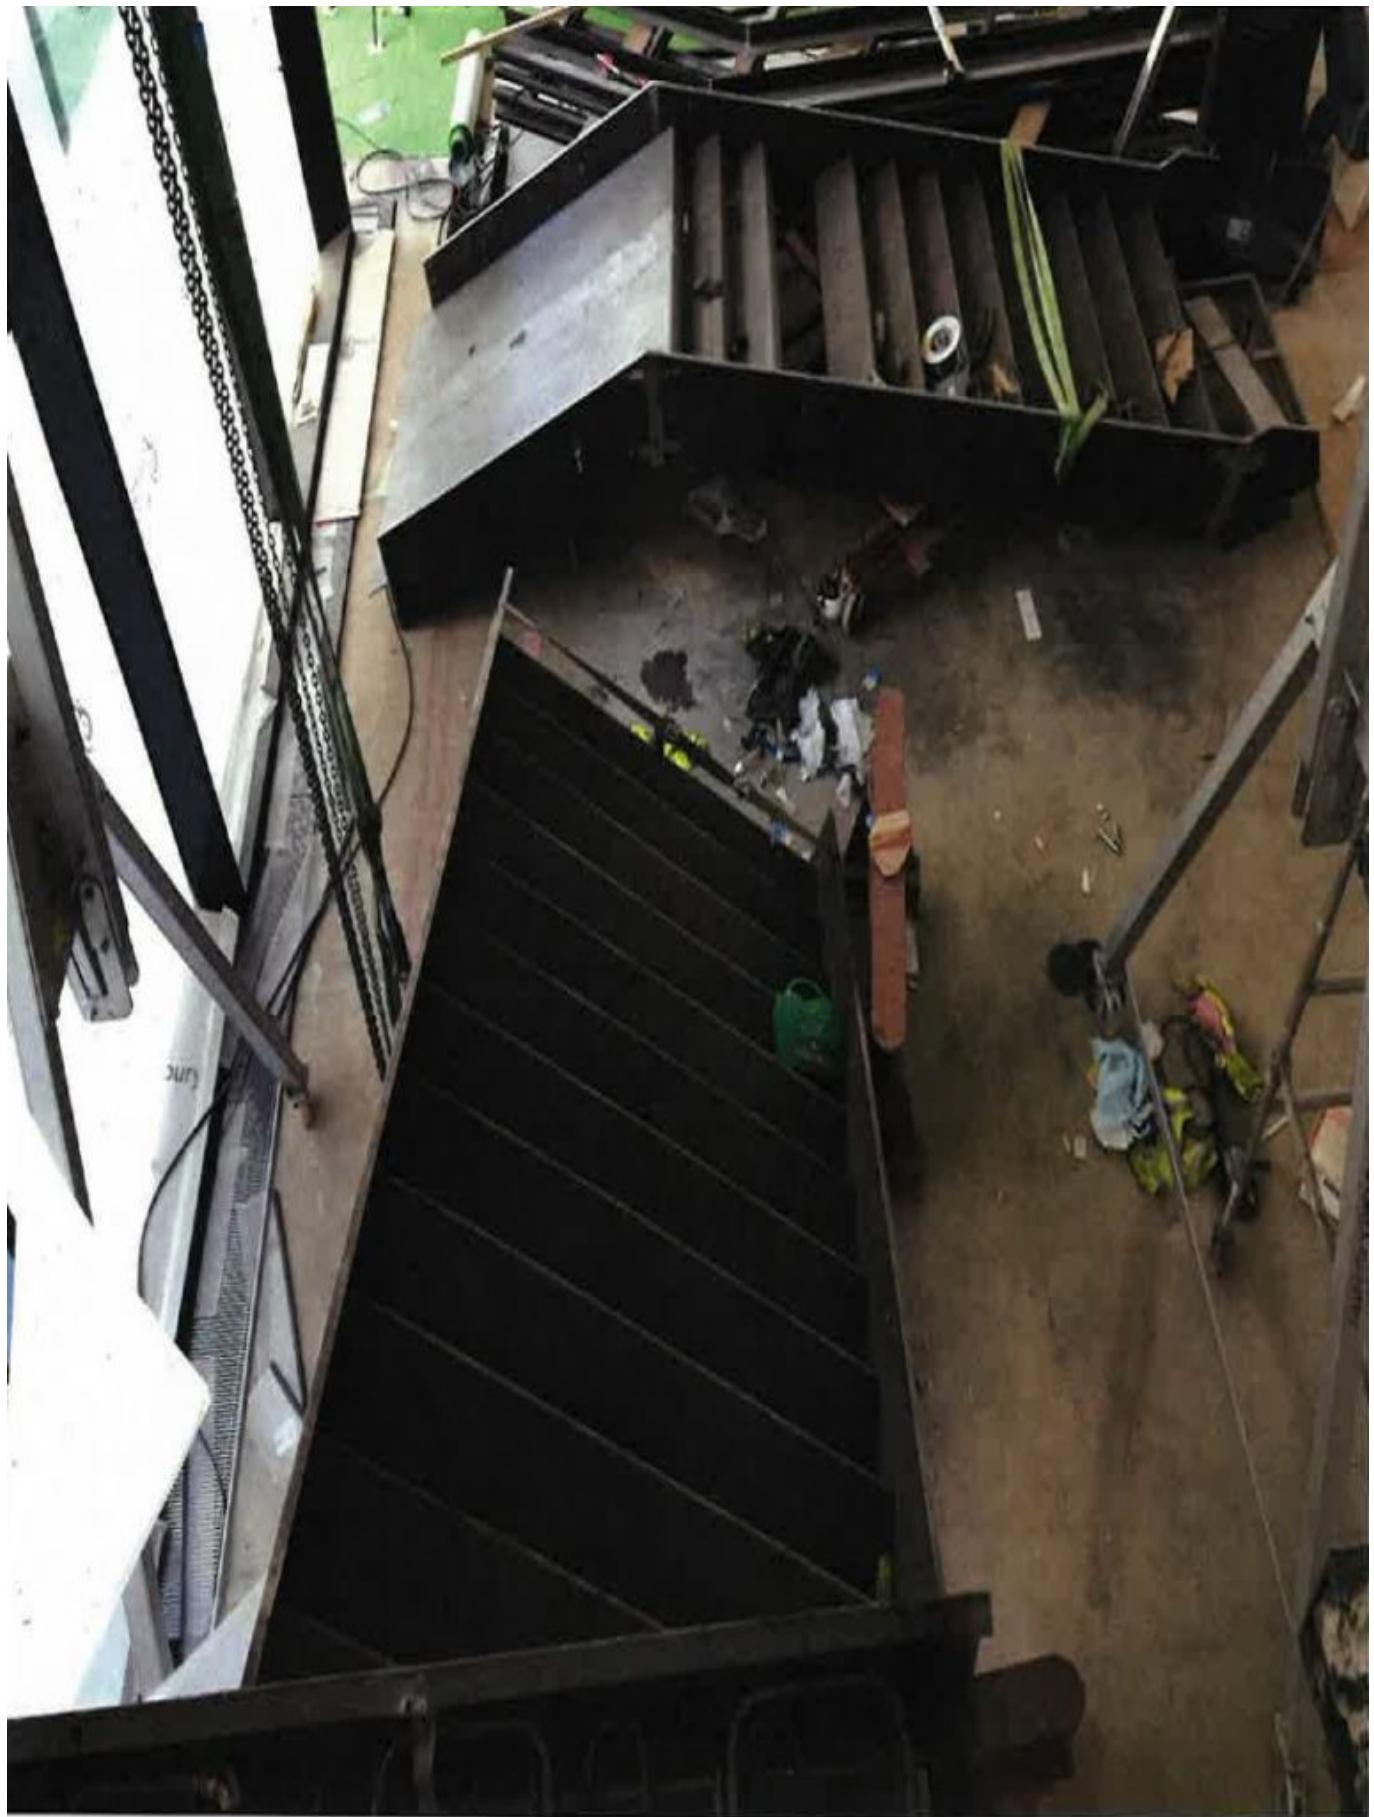
Westminster Magistrates' Court heard that on 19 July 2018 Dragos Sultana suffered serious injuries when a section of staircase weighing 1.7 tonnes fell and trapped his leg. The staircase was being lifted into position when one of the fabric slings supporting the load failed, causing one side of the staircase to drop and striking Mr Sultana. His injuries resulted in the amputation of his leg just below the groin.

An investigation by the Health and Safety Executive (HSE) found that Leyton Group Construction Ltd failed to properly plan the lifting operation. The lift plan was not specific to the job and the method statement lacked the level of detail required about the load, how it should be slung and how it

should be lifted. This resulted in the slings being stretched across the sharp metal edges of the staircase stringers, which caused a shearing action and ultimate failure of one the slings.

“The method employed for lifting the staircase was unsafe. This case highlights the need for duty holders to properly plan all lifting operations before work is carried out to manage the risk of injury to workers. This incident could so easily have been avoided by simply carrying out correct control measures and safe working practices.
