Waste management company fined after employee falls from height

- Worker broke leg after falling from compost screening machine while clearing blockage.
- HSE investigation found company failed to assess risks and provide safe system of work.
- Employees were able to bypass safety measures while cleaning machinery.

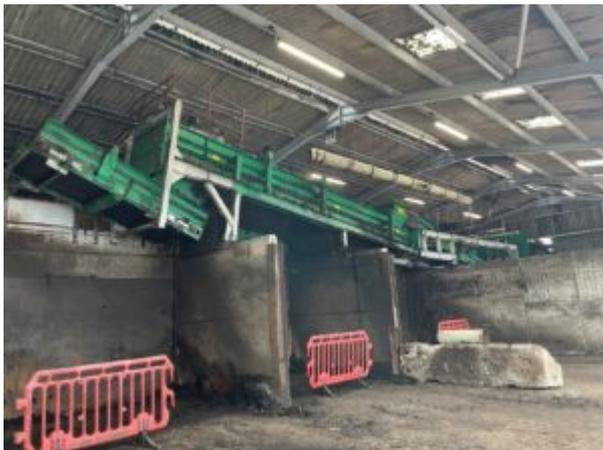
The machine was suspended at height within a large barn and lacked sufficient measures to prevent falls. As Mr Pateman climbed onto the machine he slipped, trapping his left leg between the machine and its frame.

Compost screening machine

The momentum and lack of guardrails around the fan housing caused Mr Pateman to fall backwards onto the gantry, striking his head on a handrail while his leg remained trapped. He sustained a broken leg which required surgery to insert a metal plate and screws.

An investigation by the Health and Safety Executive (HSE) found that Woodhorn Group Limited had failed to assess the risks associated with cleaning the machine, including the risk of falls from height from the unguarded edges around the fan housing.

The company's standard operating procedure also failed to provide employees with instructions on how to safely clean and unblock the fan housing. The investigation further found the company had failed to prevent access to dangerous parts of the machine, with the interlocked gate not preventing access to employees during the cleaning process for the 'stars' – rotating

discs used to break down larger clumps of compost

"The measures implemented by Woodhorn Group after HSE's intervention, including new guarded working platforms around the fan housing and over the 'stars', demonstrate what was reasonably practicable and should have been in place all along."
