# “Wonderful, kind and generous man” killed in forklift truck incident

- Chris Keegan died after being fatally injured at his place of work
- West Yorkshire plant hire company fined £433,550
- HSE found the forklift had not had a full inspection to ensure it was safe to operate after repairs.

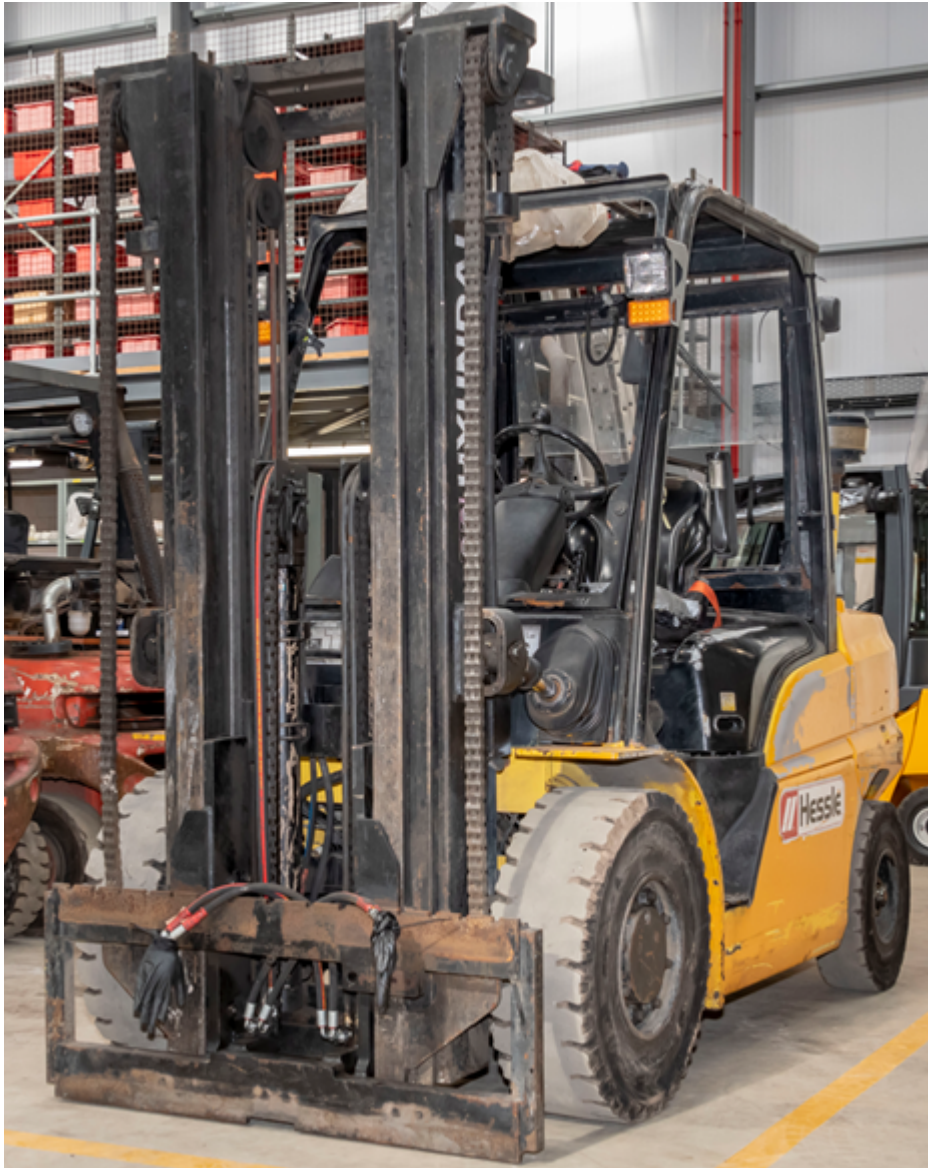
An investigation by the Health and Safety Executive (HSE) found that the forklift had not been subject to a full inspection to ensure it was safe to operate. Examination of the forklift by HSE after the accident found several other defects which should have been identified and rectified before it was operated.

Forklift Truck involved in accident

HSE guidance states that employers should ensure that work equipment – such as a forklift truck – has been properly maintained and inspected if necessary to ensure it remains in a safe condition to operate. HSE guidance also states that where seatbelts are fitted to a counterbalance forklift truck, they should be used. Further guidance for rider-operated lift trucks can be found at HSE's website.

Speaking after the hearing HSE inspector, David Beaton, said: "This was a tragic and preventable death. Mr Keegan was placed at undue risk by operating a machine with underlying maintenance defects, which he would have been unaware of when attempting to reverse the forklift in the dark onto a trailer
